OIL ANALYSIS REPORT

Area
3 Calender Line
 Machine Id
42-0384 Banbury
 Component
Gearbox
 Fluid
SUNOCO SUNEP 320 (51 GAL)

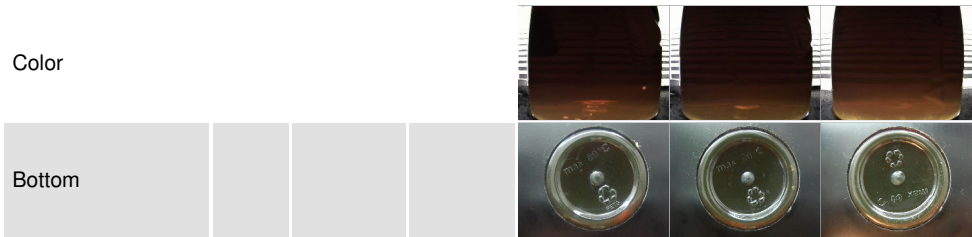
SAMPLE IMAGES	method	limit/base	current	history1	history2
---------------	--------	------------	---------	----------	----------

VISUAL	method	limit/base	current	history1	history2
White Metal	scalar	Visual*	NONE	NONE	NONE
Yellow Metal	scalar	Visual*	NONE	NONE	NONE
Precipitate	scalar	Visual*	NONE	NONE	NONE
Silt	scalar	Visual*	NONE	NONE	NONE
Debris	scalar	Visual*	NONE	NONE	NONE
Sand/Dirt	scalar	Visual*	NONE	NONE	NONE
Appearance	scalar	Visual*	NORML	NORML	NORML
Odor	scalar	Visual*	NORML	NORML	NORML
Emulsified Water	scalar	Visual*	>0.2	NEG	NEG
Free Water	scalar	Visual*		NEG	NEG

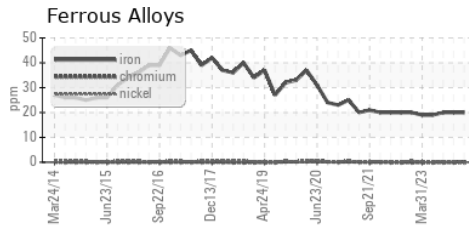
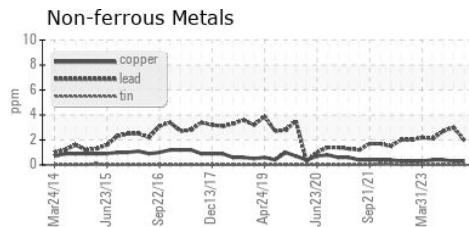
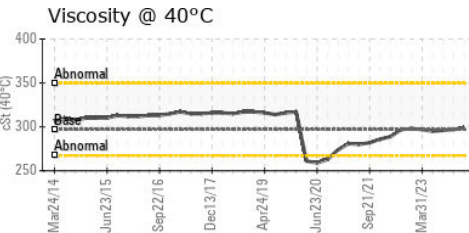
GRAPHS

method	limit/base	current	history1	history2
Iron	ppm	ASTM D5185(m) >200	20	20	20
Chromium	ppm	ASTM D5185(m) >15	0	0	0
Nickel	ppm	ASTM D5185(m) >15	0	<1	<1
Titanium	ppm	ASTM D5185(m)	0	0	0
Silver	ppm	ASTM D5185(m)	0	0	<1
Aluminum	ppm	ASTM D5185(m) >25	0	<1	<1
Lead	ppm	ASTM D5185(m) >100	2	3	3
Copper	ppm	ASTM D5185(m) >200	<1	<1	<1
Tin	ppm	ASTM D5185(m) >25	0	0	0
Antimony	ppm	ASTM D5185(m) >5	0	0	0
Vanadium	ppm	ASTM D5185(m)	0	0	0
Beryllium	ppm	ASTM D5185(m)	0	0	0
Cadmium	ppm	ASTM D5185(m)	0	0	0

Resample at the next service interval to monitor.
