OIL ANALYSIS REPORT

4 Calender Line

38-0066 Dropmill

Gearbox

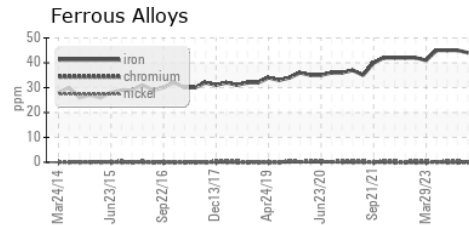
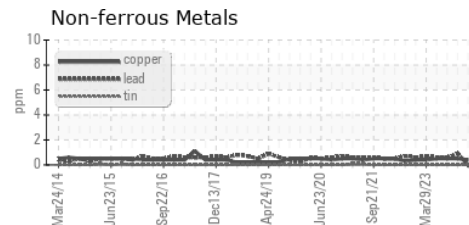
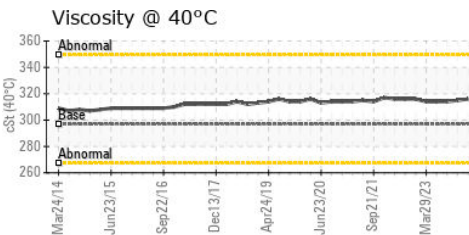
GRAPHS

All component wear rates are normal.

There is no indication of any contamination in the oil.

The condition of the oil is acceptable for the time in service.

Resample at the next service interval to monitor.
