OIL ANALYSIS REPORT

Machine Id
EPIROC SX1030 SCP218

Component
Rear Differential

Fluid
PENNZOIL SYNTHETIC SAE 75W140 GL-5 (--- GAL)

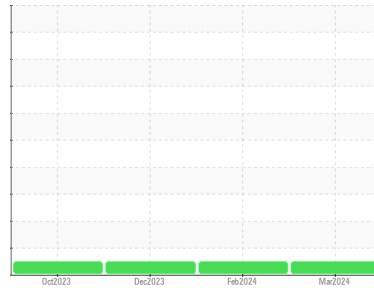
Sample Rating Trend

NORMAL

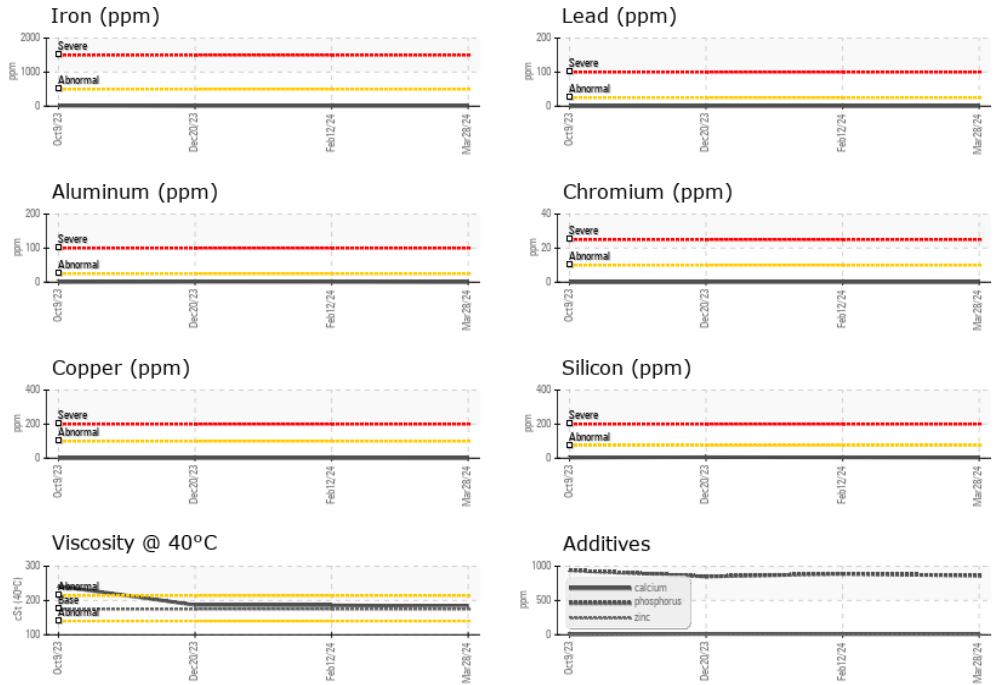
GRAPHS

All component wear rates are normal.

There is no indication of any contamination in the oil.

The condition of the oil is acceptable for the time in service.

Resample at the next service interval to monitor.
