OIL ANALYSIS REPORT

Machine Id
EPIROC SX1030 SCP218

Component
Front Differential

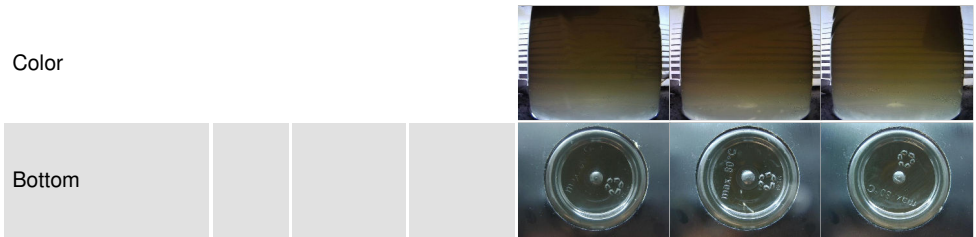
SAMPLE IMAGES	method	limit/base	current	history1	history2
---------------	--------	------------	---------	----------	----------

VISUAL	method	limit/base	current	history1	history2
White Metal	scalar	Visual*	NONE	NONE	NONE
Yellow Metal	scalar	Visual*	NONE	NONE	NONE
Precipitate	scalar	Visual*	NONE	NONE	NONE
Silt	scalar	Visual*	NONE	NONE	NONE
Debris	scalar	Visual*	NONE	NONE	NONE
Sand/Dirt	scalar	Visual*	NONE	NONE	NONE
Appearance	scalar	Visual*	NORML	NORML	NORML
Odor	scalar	Visual*	NORML	NORML	NORML
Emulsified Water	scalar	Visual*	>.2	NEG	NEG
Free Water	scalar	Visual*		NEG	NEG

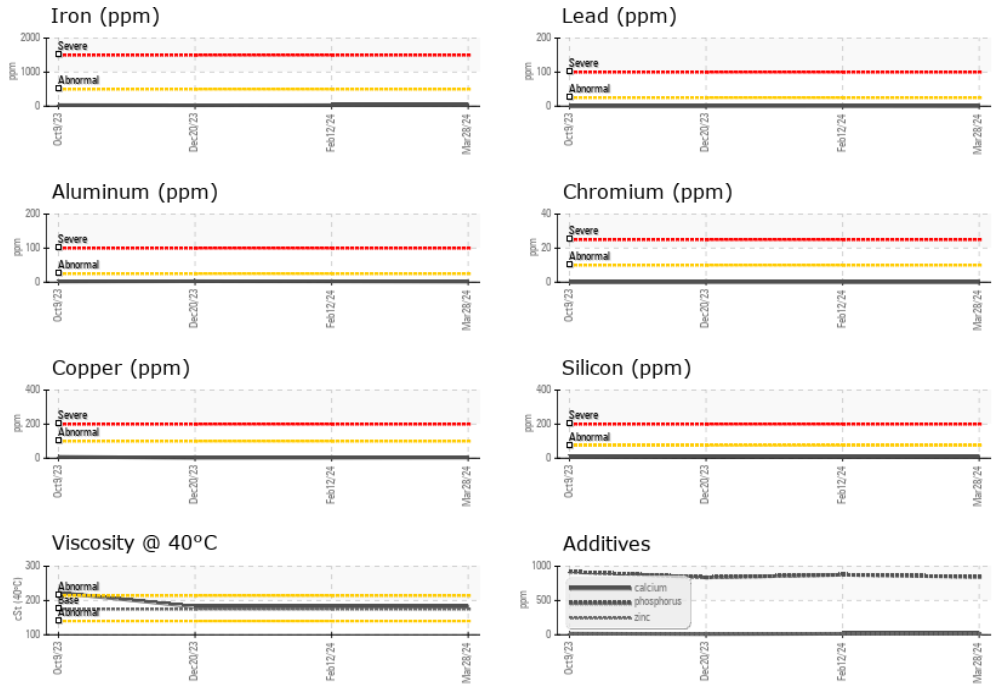
GRAPHS

All component wear rates are normal.

WEAR METALS		method	limit/base	current	history1	history2
Iron	ppm	ASTM D5185(m)	>500	36	31	27
Chromium	ppm	ASTM D5185(m)	>10	0	0	0
Nickel	ppm	ASTM D5185(m)	>10	0	<1	<1
Titanium	ppm	ASTM D5185(m)		0	0	0
Silver	ppm	ASTM D5185(m)		0	0	0
Aluminum	ppm	ASTM D5185(m)	>25	2	2	3
Lead	ppm	ASTM D5185(m)	>25	0	<1	0
Copper	ppm	ASTM D5185(m)	>100	4	3	3
Tin	ppm	ASTM D5185(m)	>10	0	0	0
Antimony	ppm	ASTM D5185(m)	>5	0	0	0
Vanadium	ppm	ASTM D5185(m)		0	0	0
Beryllium	ppm	ASTM D5185(m)		0	0	0
Cadmium	ppm	ASTM D5185(m)		0	0	0

Resample at the next service interval to monitor.
