OIL ANALYSIS REPORT

Machine Id
CATERPILLAR R1600G SCP215
 Component
Rear Differential
 Fluid
PETRO CANADA PRODURO TO-4 SAE 50 (--- GAL)

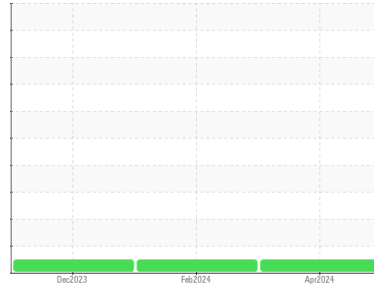
Sample Rating Trend

NORMAL

All component wear rates are normal.

There is no indication of any contamination in the oil.

The condition of the oil is acceptable for the time in service.

Resample at the next service interval to monitor.

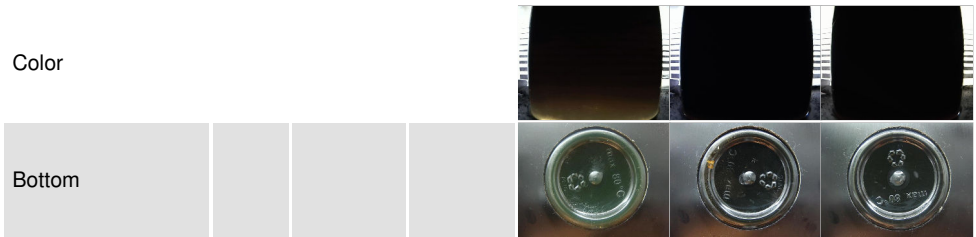
SAMPLE IMAGES	method	limit/base	current	history1	history2
---------------	--------	------------	---------	----------	----------

VISUAL	method	limit/base	current	history1	history2
White Metal	scalar	Visual*	NONE	NONE	NONE
Yellow Metal	scalar	Visual*	NONE	NONE	NONE
Precipitate	scalar	Visual*	NONE	NONE	NONE
Silt	scalar	Visual*	NONE	NONE	NONE
Debris	scalar	Visual*	NONE	NONE	VLITE
Sand/Dirt	scalar	Visual*	NONE	NONE	LIGHT
Appearance	scalar	Visual*	NORML	NORML	NORML
Odor	scalar	Visual*	NORML	NORML	NORML
Emulsified Water	scalar	Visual*	>.2	NEG	NEG
Free Water	scalar	Visual*		NEG	NEG

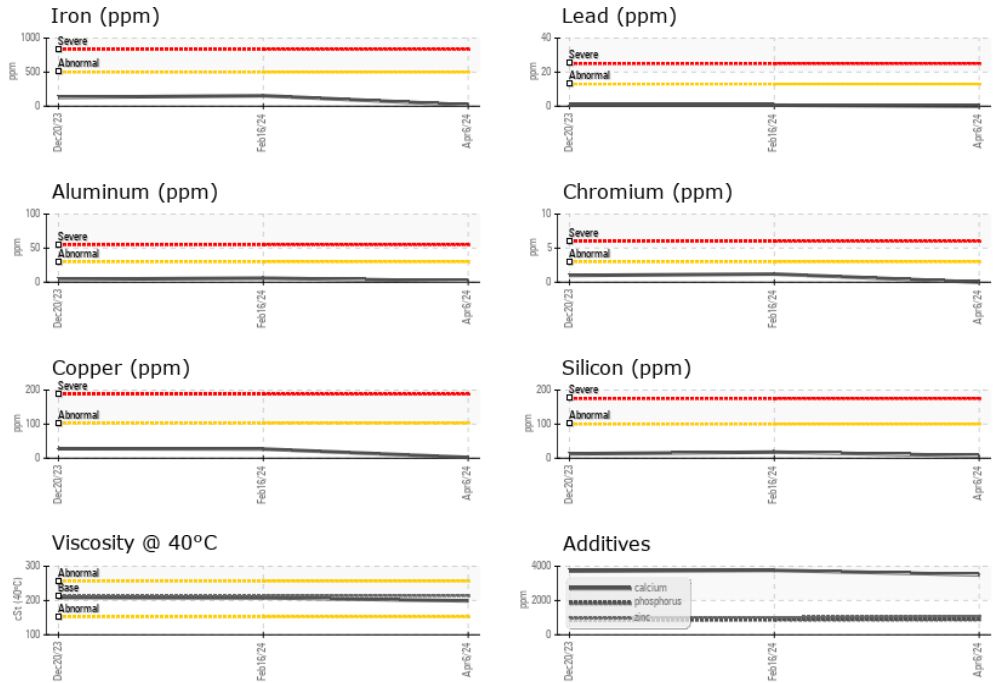
GRAPHS

method	limit/base	current	history1	history2	
Iron	ppm	ASTM D5185(m)	>500	19	154	130
Chromium	ppm	ASTM D5185(m)	>3	0	1	1
Nickel	ppm	ASTM D5185(m)	>3	0	<1	<1
Titanium	ppm	ASTM D5185(m)	>2	0	0	0
Silver	ppm	ASTM D5185(m)	>2	<1	0	0
Aluminum	ppm	ASTM D5185(m)	>30	2	6	4
Lead	ppm	ASTM D5185(m)	>13	0	<1	<1
Copper	ppm	ASTM D5185(m)	>103	2	27	28
Tin	ppm	ASTM D5185(m)	>5	0	1	1
Antimony	ppm	ASTM D5185(m)	>5	0	2	2
Vanadium	ppm	ASTM D5185(m)		0	0	0
Beryllium	ppm	ASTM D5185(m)		0	0	0
Cadmium	ppm	ASTM D5185(m)		0	0	0
