# OIL ANALYSIS REPORT

Machine Id  
**CATERPILLAR R1600G SCP215**  
 Component  
**Transmission (Auto)**  
 Fluid  
**PETRO CANADA PRODURO TO-4 SAE 50 (--- GAL)**

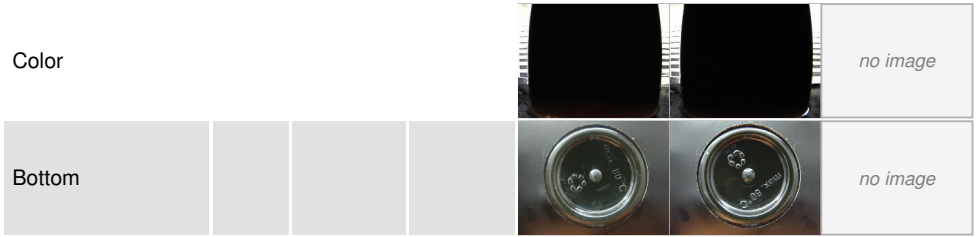
SAMPLE IMAGES	method	limit/base	current	history1	history2
---------------	--------	------------	---------	----------	----------

VISUAL	method	limit/base	current	history1	history2
White Metal	scalar	Visual*	NONE	NONE	---
Yellow Metal	scalar	Visual*	NONE	NONE	---
Precipitate	scalar	Visual*	NONE	NONE	---
Silt	scalar	Visual*	NONE	NONE	---
Debris	scalar	Visual*	NONE	NONE	---
Sand/Dirt	scalar	Visual*	NONE	NONE	---
Appearance	scalar	Visual*	NORML	NORML	---
Odor	scalar	Visual*	NORML	NORML	---
Emulsified Water	scalar	Visual*	>0.1	NEG	---
Free Water	scalar	Visual*		NEG	---
