OIL ANALYSIS REPORT

SP12

Hydraulic System

AW HYDRAULIC OIL ISO 46 (--- GAL)

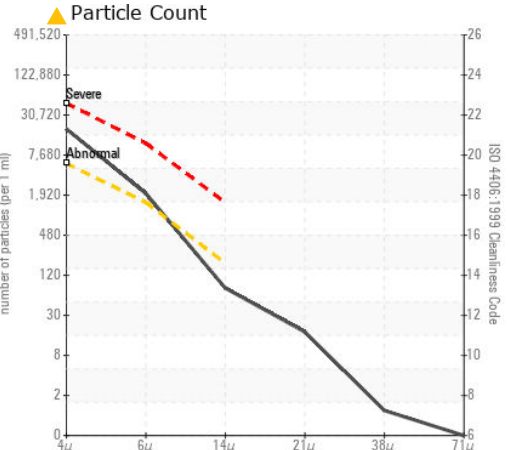
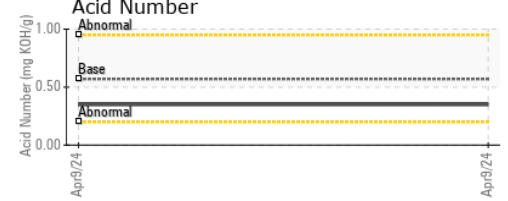
GRAPHS

There is a moderate amount of silt (particulates < 14 microns in size) present in the oil.

FLUID CLEANLINESS		method	limit/base	current	history1	history2
Particles >4µm		ASTM D7647	>5000	▲ 16481	---	---
Particles >6µm		ASTM D7647	>1300	● 1780	---	---
Particles >14µm		ASTM D7647	>160	68	---	---
Particles >21µm		ASTM D7647	>40	15	---	---
Particles >38µm		ASTM D7647	>10	1	---	---
Particles >71µm		ASTM D7647	>3	0	---	---
Oil Cleanliness		ISO 4406 (c)	>19/17/14	▲ 21/18/13	---	---

The AN level is acceptable for this fluid. The oil is still serviceable provided that the contaminant(s) can be reduced to acceptable levels.
