OIL ANALYSIS REPORT

Machine Id
1000004670

Component
Hydraulic System

Fluid
AW HYDRAULIC OIL ISO 46 (1200 LTR)

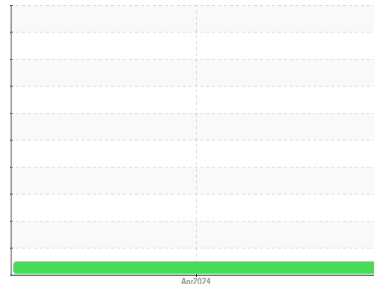
Sample Rating Trend

NORMAL

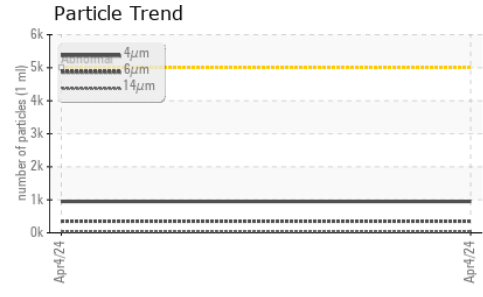
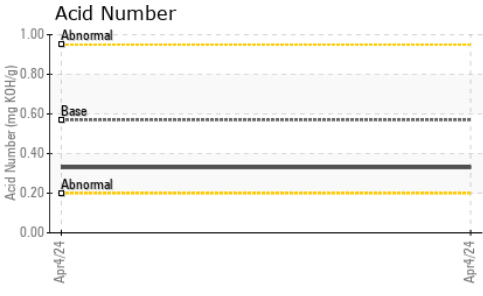
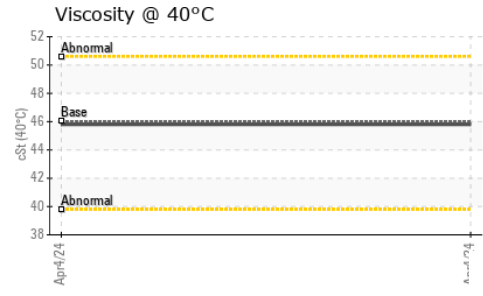
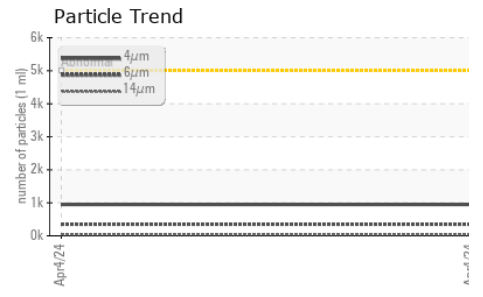
All component wear rates are normal.

The system cleanliness is acceptable for your target ISO 4406 cleanliness code. The system and fluid cleanliness is acceptable.

The AN level is acceptable for this fluid. The condition of the oil is suitable for further service.
