OIL ANALYSIS REPORT

Machine Id
CATERPILLAR R1600H SCP222
 Component
Rear Differential
 Fluid
PETRO CANADA PRODURO TO-4 SAE 50 (--- GAL)

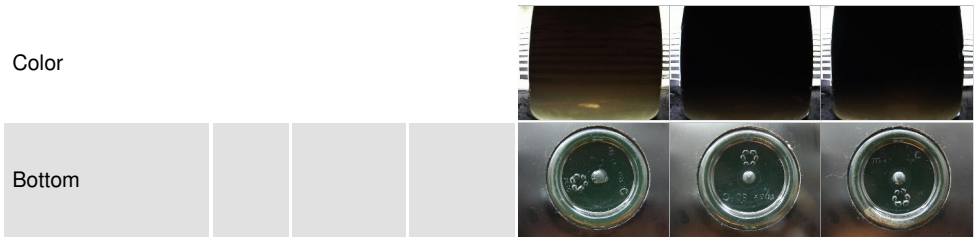
SAMPLE IMAGES	method	limit/base	current	history1	history2
---------------	--------	------------	---------	----------	----------

VISUAL	method	limit/base	current	history1	history2
White Metal	scalar	Visual*	NONE	NONE	NONE
Yellow Metal	scalar	Visual*	NONE	NONE	NONE
Precipitate	scalar	Visual*	NONE	NONE	NONE
Silt	scalar	Visual*	NONE	NONE	NONE
Debris	scalar	Visual*	NONE	NONE	NONE
Sand/Dirt	scalar	Visual*	NONE	NONE	NONE
Appearance	scalar	Visual*	NORML	NORML	NORML
Odor	scalar	Visual*	NORML	NORML	NORML
Emulsified Water	scalar	Visual*	>.2	NEG	NEG
Free Water	scalar	Visual*		NEG	NEG

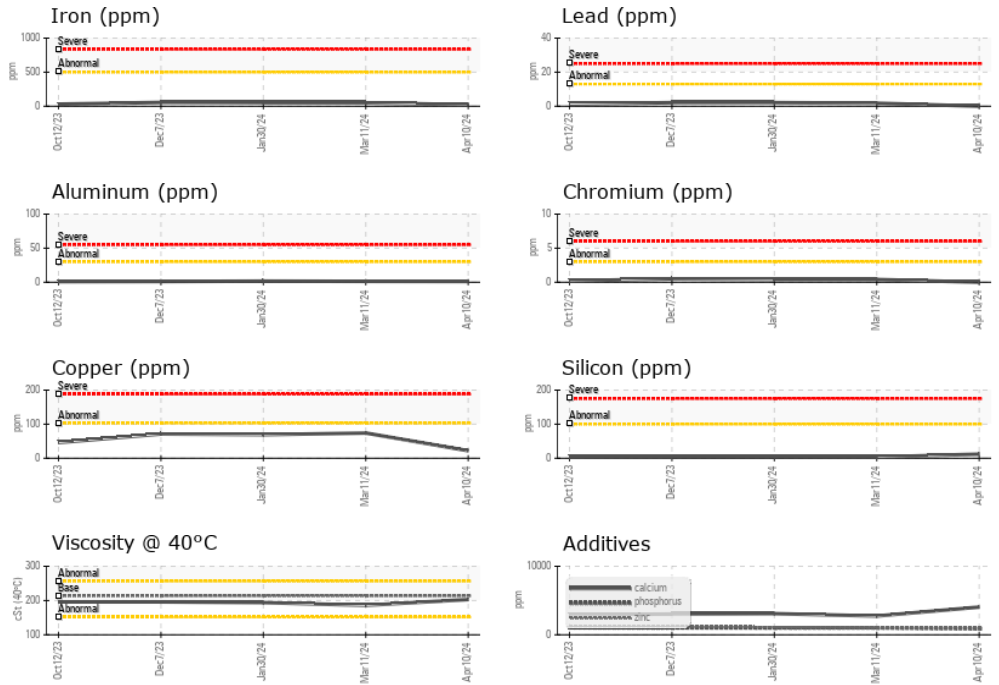
GRAPHS

All component wear rates are normal.

There is no indication of any contamination in the oil.

The condition of the oil is acceptable for the time in service.

Resample at the next service interval to monitor.
