# OIL ANALYSIS REPORT

Area  
**RONI**  
 Machine Id  
**454**  
 Component  
**Rear Axle**  
 Fluid  
**PETRO CANADA TRAXON 80W90 (--- GAL)**

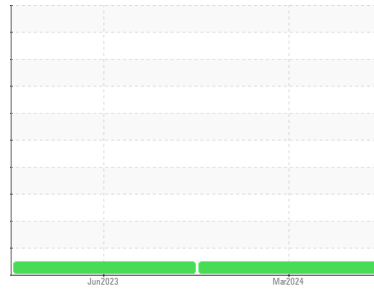
## Sample Rating Trend

**NORMAL**

**Wear**  
 All component wear rates are normal.

**Contamination**  
 There is no indication of any contamination in the oil.

**Fluid Condition**  
 The condition of the oil is acceptable for the time in service.

**Recommendation**  
 Resample at the next service interval to monitor.
