OIL ANALYSIS REPORT

Machine Id
VOLVO L70H 622774
 Component
Front Axle
 Fluid
VOLVO WB 102 (--- GAL)

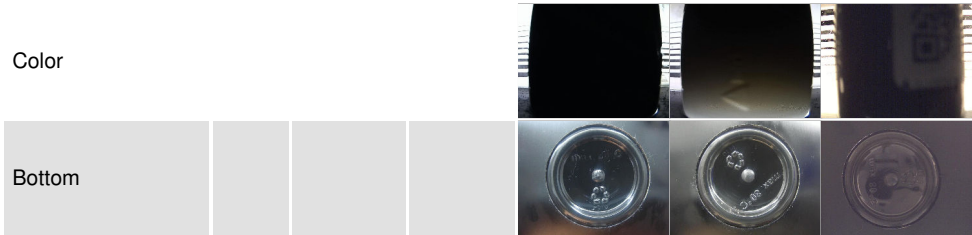
SAMPLE IMAGES	method	limit/base	current	history1	history2
---------------	--------	------------	---------	----------	----------

VISUAL	method	limit/base	current	history1	history2
White Metal	scalar	Visual*	NONE	NONE	NONE
Yellow Metal	scalar	Visual*	NONE	NONE	NONE
Precipitate	scalar	Visual*	NONE	NONE	NONE
Silt	scalar	Visual*	NONE	NONE	NONE
Debris	scalar	Visual*	NONE	NONE	NONE
Sand/Dirt	scalar	Visual*	NONE	NONE	NONE
Appearance	scalar	Visual*	NORML	NORML	NORML
Odor	scalar	Visual*	NORML	NORML	NORML
Emulsified Water	scalar	Visual*	>0.2	NEG	NEG
Free Water	scalar	Visual*		NEG	NEG

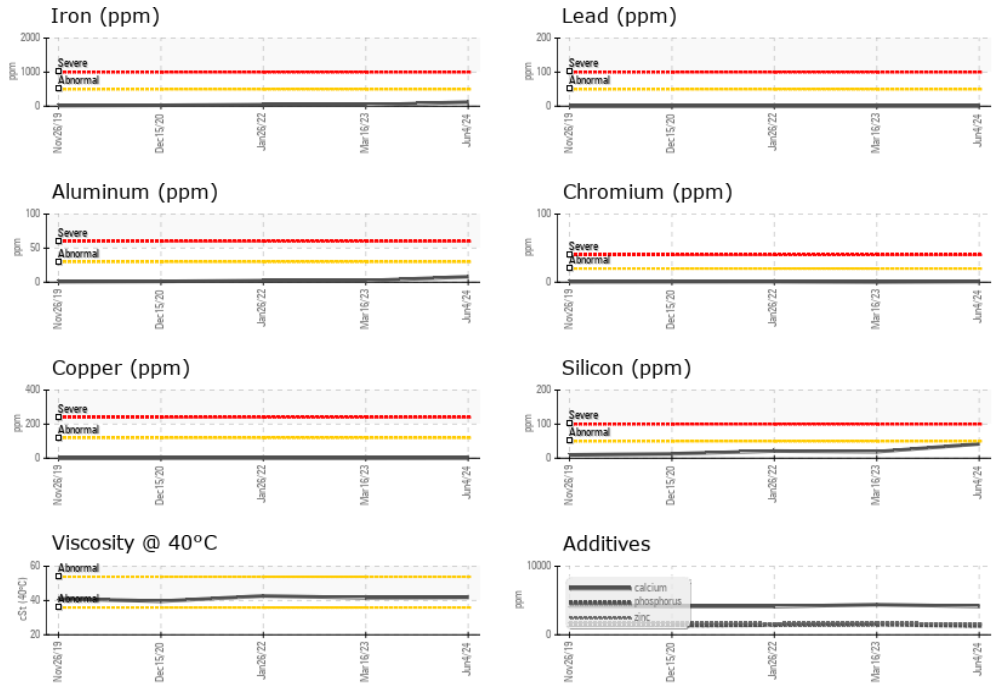
GRAPHS

method	limit/base	current	history1	history2	
Iron	ppm	ASTM D5185(m)	>500	122	34	46
Chromium	ppm	ASTM D5185(m)	>20	1	<1	<1
Nickel	ppm	ASTM D5185(m)	>10	<1	0	<1
Titanium	ppm	ASTM D5185(m)		<1	<1	<1
Silver	ppm	ASTM D5185(m)		0	0	<1
Aluminum	ppm	ASTM D5185(m)	>30	8	2	2
Lead	ppm	ASTM D5185(m)	>50	0	0	0
Copper	ppm	ASTM D5185(m)	>120	<1	0	<1
Tin	ppm	ASTM D5185(m)	>20	0	0	0
Antimony	ppm	ASTM D5185(m)	>5	0	0	<1
Vanadium	ppm	ASTM D5185(m)		0	0	0
Beryllium	ppm	ASTM D5185(m)		0	0	0
Cadmium	ppm	ASTM D5185(m)		0	0	0

method	limit/base	current	history1	history2	
Silicon	ppm	ASTM D5185(m)	>50	42	19	21
Sodium	ppm	ASTM D5185(m)		8	11	11
Potassium	ppm	ASTM D5185(m)	>20	6	1	2

Resample at the next service interval to monitor.
