OIL ANALYSIS REPORT

Machine Id
EPIROC ST18 SCP203
 Component
Rear Left Planetary
 Fluid
GEAR OIL SAE 80W140 (--- GAL)

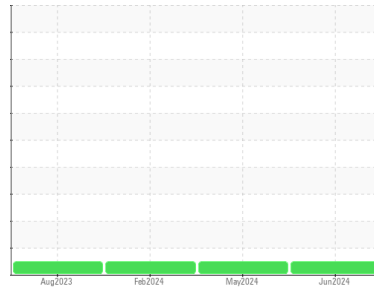
Sample Rating Trend

NORMAL

All component wear rates are normal.

There is no indication of any contamination in the oil.

The condition of the oil is acceptable for the time in service.

Resample at the next service interval to monitor.

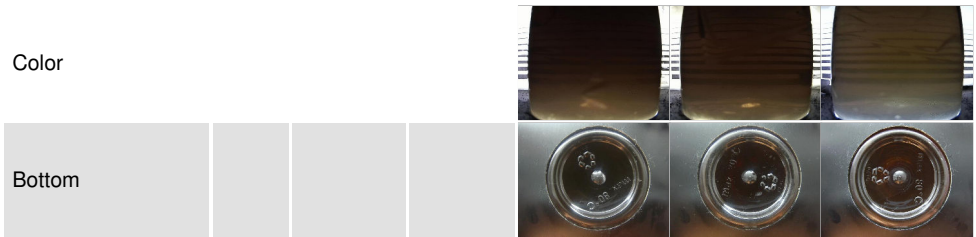
SAMPLE IMAGES	method	limit/base	current	history1	history2
---------------	--------	------------	---------	----------	----------

VISUAL	method	limit/base	current	history1	history2
White Metal	scalar	Visual*	NONE	NONE	NONE
Yellow Metal	scalar	Visual*	NONE	NONE	NONE
Precipitate	scalar	Visual*	NONE	NONE	NONE
Silt	scalar	Visual*	NONE	NONE	NONE
Debris	scalar	Visual*	NONE	NONE	NONE
Sand/Dirt	scalar	Visual*	NONE	NONE	NONE
Appearance	scalar	Visual*	NORML	NORML	NORML
Odor	scalar	Visual*	NORML	NORML	NORML
Emulsified Water	scalar	Visual*	>0.2	NEG	NEG
Free Water	scalar	Visual*		NEG	NEG

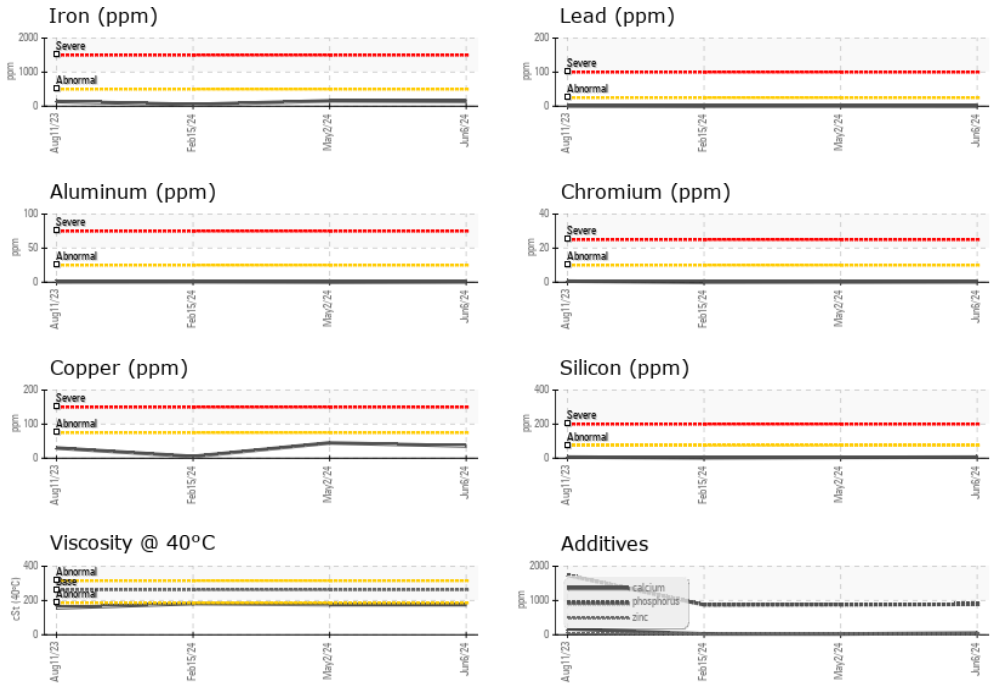
GRAPHS

WEAR METALS		method	limit/base	current	history1	history2
Iron	ppm	ASTM D5185(m)	>500	145	158	50
Chromium	ppm	ASTM D5185(m)	>10	<1	<1	0
Nickel	ppm	ASTM D5185(m)	>10	<1	0	<1
Titanium	ppm	ASTM D5185(m)		0	0	0
Silver	ppm	ASTM D5185(m)		0	0	0
Aluminum	ppm	ASTM D5185(m)	>25	<1	0	<1
Lead	ppm	ASTM D5185(m)	>25	0	<1	0
Copper	ppm	ASTM D5185(m)	>75	36	45	5
Tin	ppm	ASTM D5185(m)	>10	<1	<1	0
Antimony	ppm	ASTM D5185(m)	>5	0	0	0
Vanadium	ppm	ASTM D5185(m)		0	0	0
Beryllium	ppm	ASTM D5185(m)		0	0	0
Cadmium	ppm	ASTM D5185(m)		0	0	0
