OIL ANALYSIS REPORT

Machine Id
EPIROC ST18 SCP203
 Component
Front Differential
 Fluid
GEAR OIL SAE 75W140 (--- GAL)

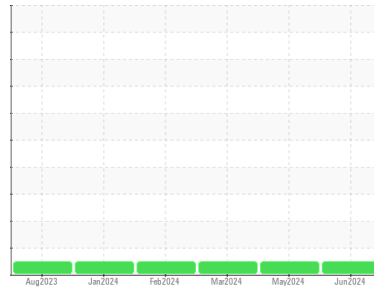
Sample Rating Trend

NORMAL

All component wear rates are normal.

There is no indication of any contamination in the oil.

The condition of the oil is acceptable for the time in service.

Resample at the next service interval to monitor.

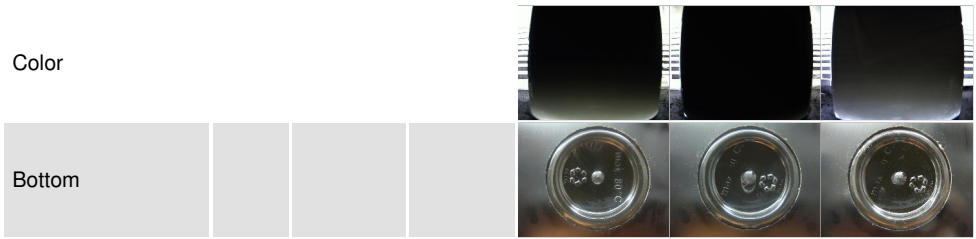
SAMPLE IMAGES	method	limit/base	current	history1	history2
---------------	--------	------------	---------	----------	----------

VISUAL	method	limit/base	current	history1	history2
White Metal	scalar	Visual*	NONE	NONE	LIGHT
Yellow Metal	scalar	Visual*	NONE	NONE	NONE
Precipitate	scalar	Visual*	NONE	NONE	NONE
Silt	scalar	Visual*	NONE	NONE	LIGHT
Debris	scalar	Visual*	NONE	NONE	NONE
Sand/Dirt	scalar	Visual*	NONE	NONE	NONE
Appearance	scalar	Visual*	NORML	NORML	NORML
Odor	scalar	Visual*	NORML	NORML	NORML
Emulsified Water	scalar	Visual*	>.2	NEG	NEG
Free Water	scalar	Visual*		NEG	NEG

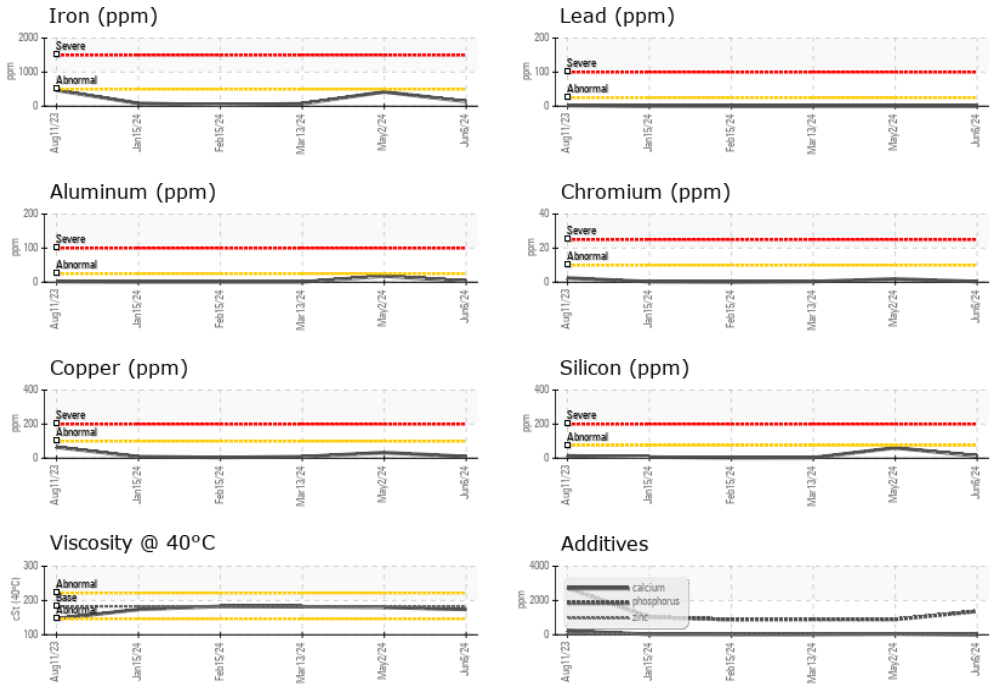
GRAPHS

WEAR METALS		method	limit/base	current	history1	history2
Iron	ppm	ASTM D5185(m)	>500	138	420	74
Chromium	ppm	ASTM D5185(m)	>10	<1	2	<1
Nickel	ppm	ASTM D5185(m)	>10	<1	<1	<1
Titanium	ppm	ASTM D5185(m)		<1	1	0
Silver	ppm	ASTM D5185(m)		0	0	<1
Aluminum	ppm	ASTM D5185(m)	>25	3	18	<1
Lead	ppm	ASTM D5185(m)	>25	0	0	0
Copper	ppm	ASTM D5185(m)	>100	10	33	9
Tin	ppm	ASTM D5185(m)	>10	<1	1	0
Antimony	ppm	ASTM D5185(m)	>5	0	0	0
Vanadium	ppm	ASTM D5185(m)		0	0	0
Beryllium	ppm	ASTM D5185(m)		0	0	0
Cadmium	ppm	ASTM D5185(m)		0	0	0

FLUID PROPERTIES	method	limit/base	current	history1	history2
Visc @ 40°C	cSt	ASTM D7279(m)	183	174	180
