OIL ANALYSIS REPORT

Machine Id
CATERPILLAR R1600H SCP222
 Component
Hydraulic System
 Fluid
HD 30 (--- GAL)

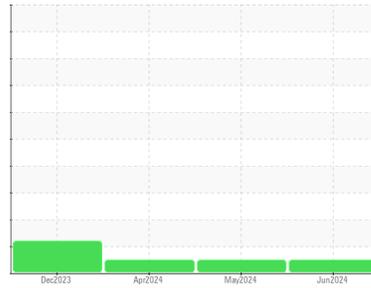
Sample Rating Trend

NORMAL

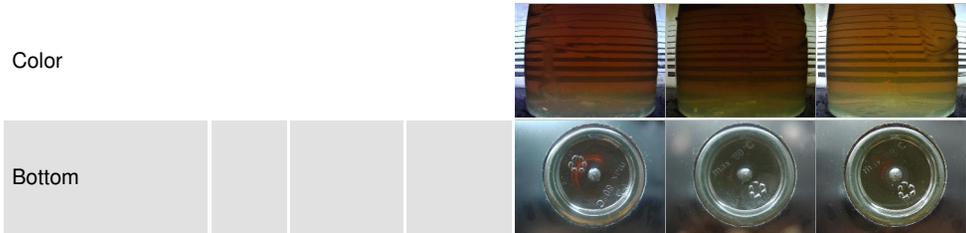
SAMPLE IMAGES	method	limit/base	current	history1	history2
---------------	--------	------------	---------	----------	----------

VISUAL	method	limit/base	current	history1	history2
White Metal	scalar	Visual*	NONE	NONE	NONE
Yellow Metal	scalar	Visual*	NONE	NONE	NONE
Precipitate	scalar	Visual*	NONE	NONE	NONE
Silt	scalar	Visual*	NONE	NONE	NONE
Debris	scalar	Visual*	NONE	NONE	NONE
Sand/Dirt	scalar	Visual*	NONE	NONE	NONE
Appearance	scalar	Visual*	NORML	NORML	NORML
Odor	scalar	Visual*	NORML	NORML	NORML
Emulsified Water	scalar	Visual*	>0.1	NEG	NEG
Free Water	scalar	Visual*		NEG	NEG

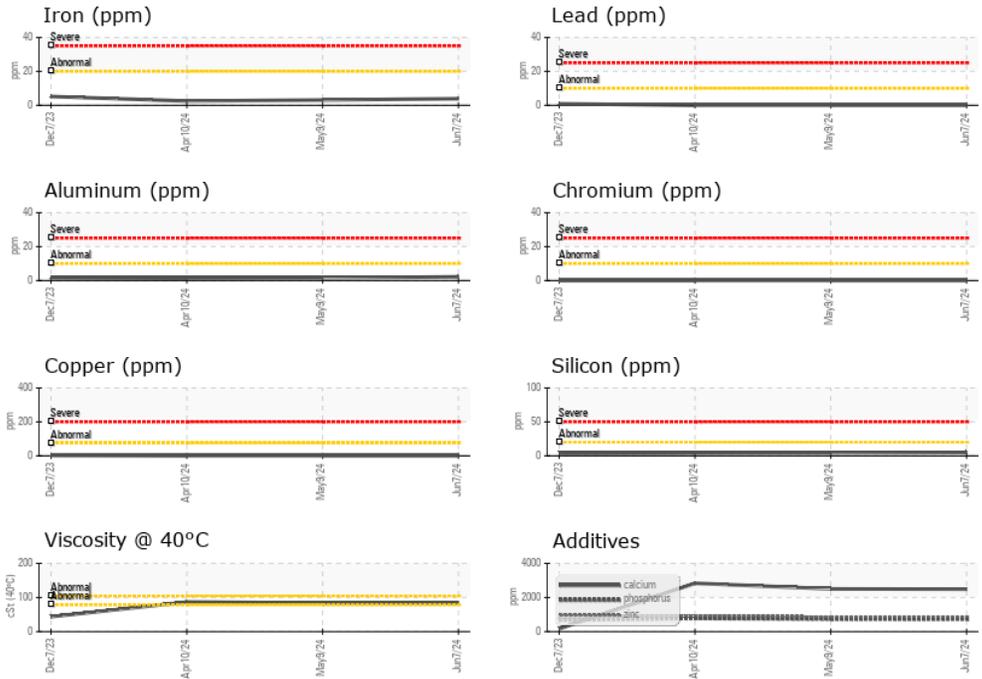
GRAPHS

All component wear rates are normal.

There is no indication of any contamination in the component(unconfirmed).

The condition of the oil is acceptable for the time in service.

Resample at the next service interval to monitor. Please contact your representative for information regarding the proper sampling kits for your service. NOTE: We recommend using MOB 2 test kits, this testkit includes Particle Count to determine the ISO cleanliness of the fluid.
