OIL ANALYSIS REPORT

Machine Id
CATERPILLAR R1600H SCP222
 Component
Transmission (Manual)
 Fluid
HD 30 (--- GAL)

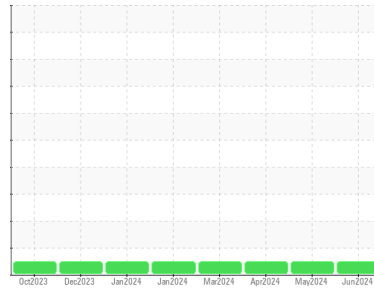
Sample Rating Trend

NORMAL

All component wear rates are normal.

There is no indication of any contamination in the fluid.

The condition of the fluid is acceptable for the time in service.

Resample at the next service interval to monitor.

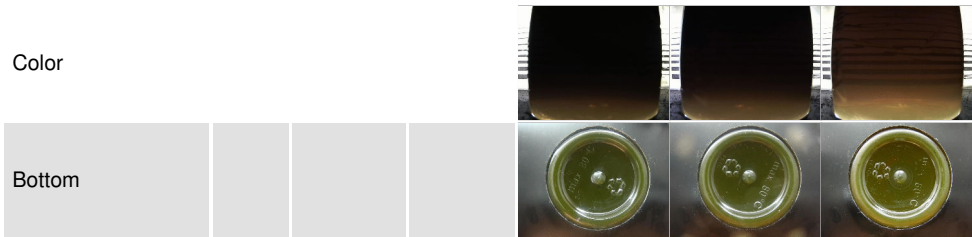
SAMPLE IMAGES	method	limit/base	current	history1	history2
---------------	--------	------------	---------	----------	----------

VISUAL	method	limit/base	current	history1	history2
White Metal	scalar	Visual*	NONE	NONE	NONE
Yellow Metal	scalar	Visual*	NONE	NONE	NONE
Precipitate	scalar	Visual*	NONE	NONE	NONE
Silt	scalar	Visual*	NONE	NONE	NONE
Debris	scalar	Visual*	NONE	NONE	VLITE
Sand/Dirt	scalar	Visual*	NONE	NONE	NONE
Appearance	scalar	Visual*	NORML	NORML	NORML
Odor	scalar	Visual*	NORML	NORML	NORML
Emulsified Water	scalar	Visual*	>0.1	NEG	NEG
Free Water	scalar	Visual*		NEG	NEG
