OIL ANALYSIS REPORT

Machine Id
CATERPILLAR R1600H SCP222
 Component
Rear Left Planetary
 Fluid
PETRO CANADA PRODURO TO-4 SAE 50 (--- GAL)

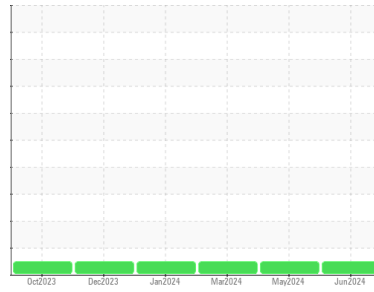
Sample Rating Trend

NORMAL

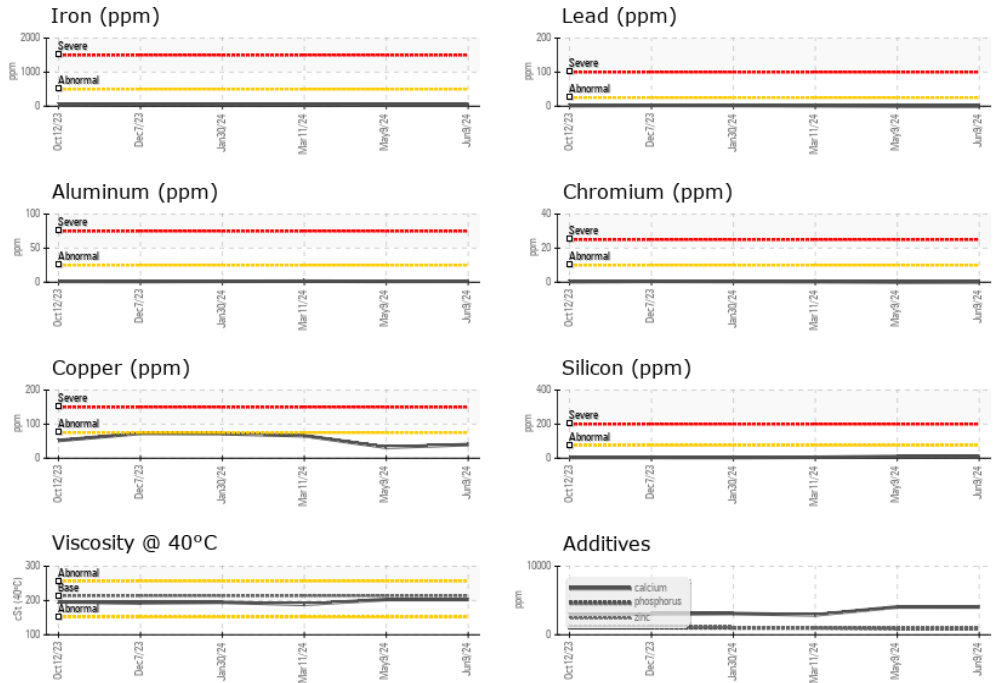
GRAPHS

All component wear rates are normal.

There is no indication of any contamination in the oil.

The condition of the oil is acceptable for the time in service.

Resample at the next service interval to monitor.
