OIL ANALYSIS REPORT

Machine Id
CATERPILLAR R1600H SCP222
 Component
Rear Right Planetary
 Fluid
PETRO CANADA PRODURO TO-4 SAE 50 (--- GAL)

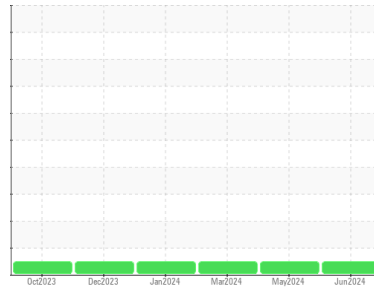
Sample Rating Trend

NORMAL

All component wear rates are normal.

There is no indication of any contamination in the oil.

The condition of the oil is acceptable for the time in service.

Resample at the next service interval to monitor.

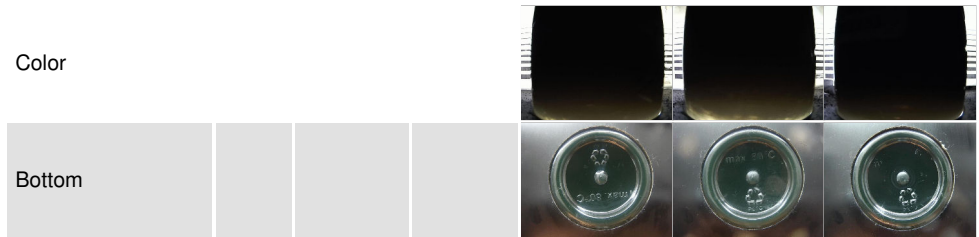
SAMPLE IMAGES	method	limit/base	current	history1	history2
---------------	--------	------------	---------	----------	----------

VISUAL	method	limit/base	current	history1	history2
White Metal	scalar	Visual*	NONE	NONE	NONE
Yellow Metal	scalar	Visual*	NONE	NONE	NONE
Precipitate	scalar	Visual*	NONE	NONE	NONE
Silt	scalar	Visual*	NONE	NONE	NONE
Debris	scalar	Visual*	NONE	NONE	NONE
Sand/Dirt	scalar	Visual*	NONE	NONE	NONE
Appearance	scalar	Visual*	NORML	NORML	NORML
Odor	scalar	Visual*	NORML	NORML	NORML
Emulsified Water	scalar	Visual*	>0.2	NEG	NEG
Free Water	scalar	Visual*		NEG	NEG

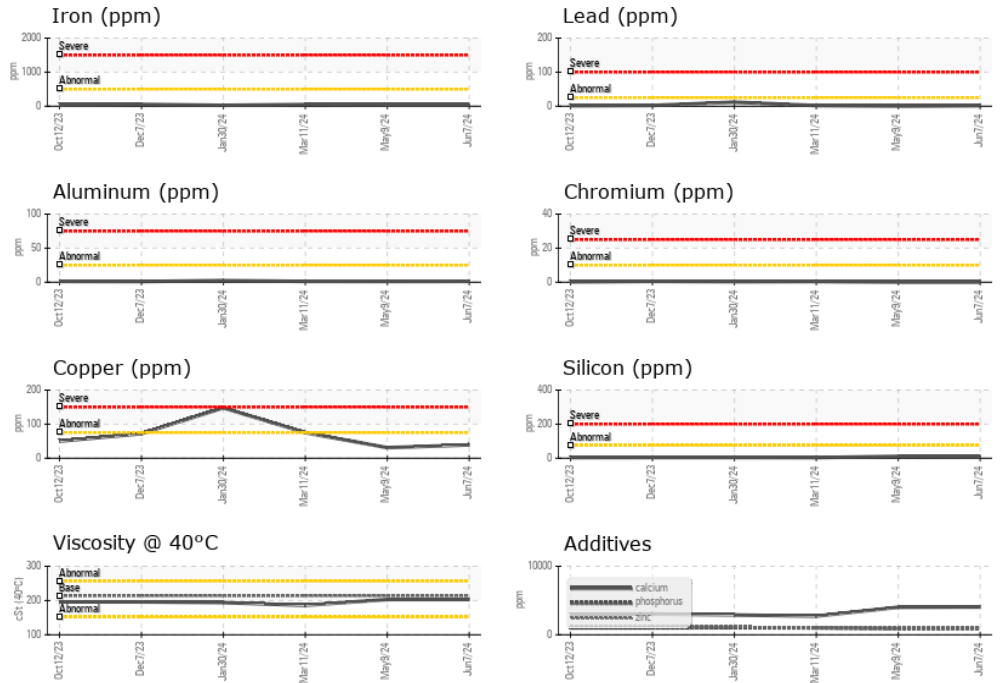
GRAPHS

method	limit/base	current	history1	history2	
Iron	ppm	ASTM D5185(m)	>500	37	34	52
Chromium	ppm	ASTM D5185(m)	>10	0	0	<1
Nickel	ppm	ASTM D5185(m)	>10	0	0	<1
Titanium	ppm	ASTM D5185(m)		0	0	0
Silver	ppm	ASTM D5185(m)		0	0	<1
Aluminum	ppm	ASTM D5185(m)	>25	1	1	1
Lead	ppm	ASTM D5185(m)	>25	2	0	2
Copper	ppm	ASTM D5185(m)	>75	39	31	75
Tin	ppm	ASTM D5185(m)	>10	<1	<1	2
Antimony	ppm	ASTM D5185(m)	>5	0	0	0
Vanadium	ppm	ASTM D5185(m)		0	0	0
Beryllium	ppm	ASTM D5185(m)		0	0	0
Cadmium	ppm	ASTM D5185(m)		0	0	0
