GREASE ANALYSIS

Area
EAST CRANE [13998089]
 Machine Id
170831 GREASE 270 WEST
 Component
Grease
 Fluid
IRVING LUBEX SYN 2 46 (--- GAL)

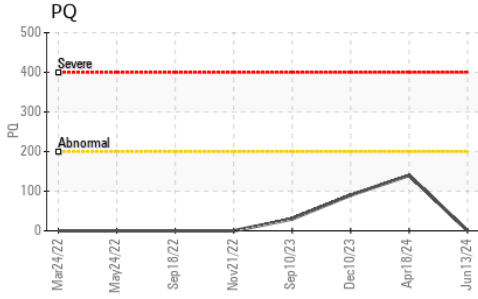
SAMPLE IMAGES	method	limit/base	current	history1	history2
Color					
Bottom					
PrtFilter

The condition of the grease is acceptable for the time in service.

method	limit/base	current	history1	history2
Grease Color	Visual* Tan/Beige	Tan	Tan	Tan
Texture	In-house*	Buttery	Buttery	Buttery
NLGI Consistency	NLGI Scale SKF Method* 2	2-3	2-3	2

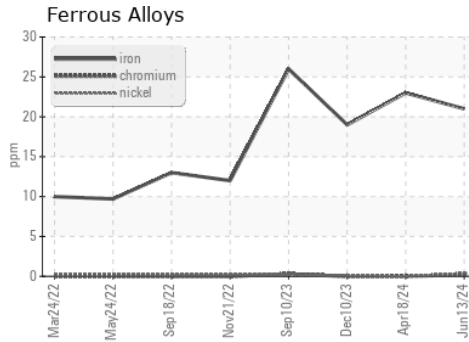
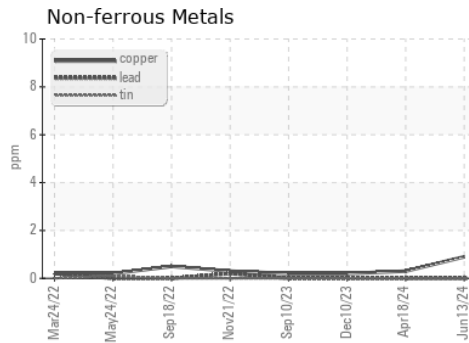
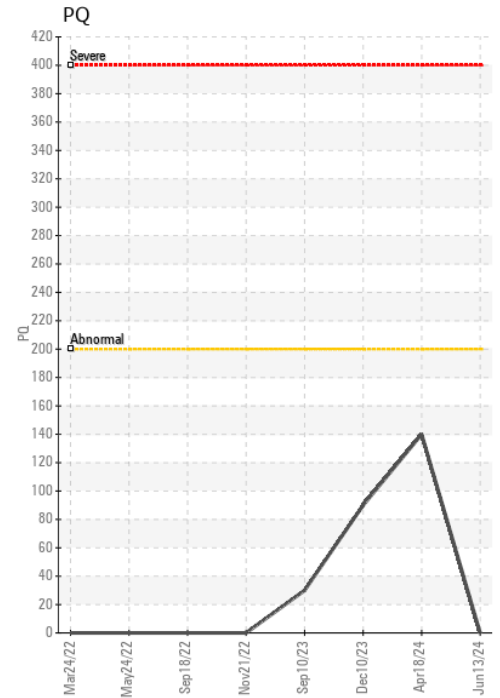
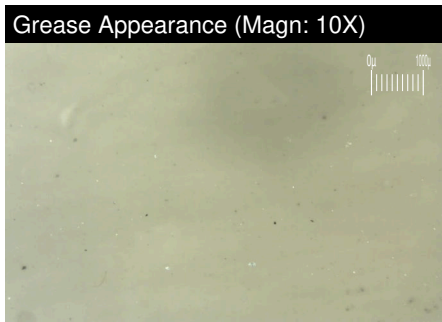
GRAPHS

All component wear rates are normal.

method	limit/base	current	history1	history2
PQ	ASTM D8184* >200	0	140	90
Iron	ppm ASTM D5185(m) >250	21	23	19
Chromium	ppm ASTM D5185(m) >10	<1	0	0
Nickel	ppm ASTM D5185(m) >5	<1	0	<1
Cadmium	ppm ASTM D5185(m)	0	0	0
Titanium	ppm ASTM D5185(m)	<1	0	0
Vanadium	ppm ASTM D5185(m)	0	0	0
Lead	ppm ASTM D5185(m) >25	0	0	0
Copper	ppm ASTM D5185(m) >75	<1	<1	<1
Tin	ppm ASTM D5185(m) >5	0	0	0
Silver	ppm ASTM D5185(m) >5	<1	0	<1

Resample at the next service interval to monitor.
