GREASE ANALYSIS

Area
EAST CRANE [13998089]
 Machine Id
170831 GREASE 180 SOUTH
 Component
Grease
 Fluid
IRVING LUBEX SYN 2 46 (--- GAL)

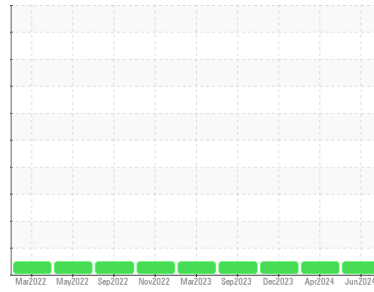
Sample Rating Trend

Wear
 All component wear rates are normal.

Grease Condition
 The condition of the grease is acceptable for the time in service.

Contaminants
 There is no indication of any contamination in the grease.

Recommendation
 Resample at the next service interval to monitor.

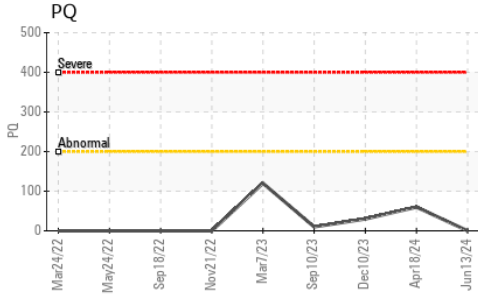
SAMPLE IMAGES	method	limit/base	current	history1	history2
Color					
Bottom					
PrtFilter

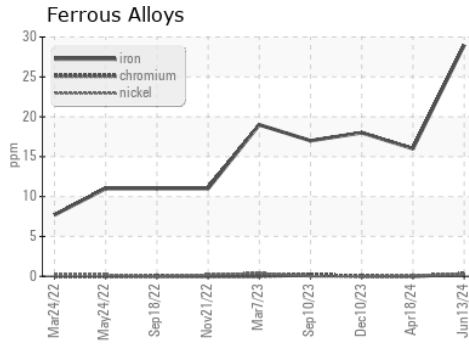
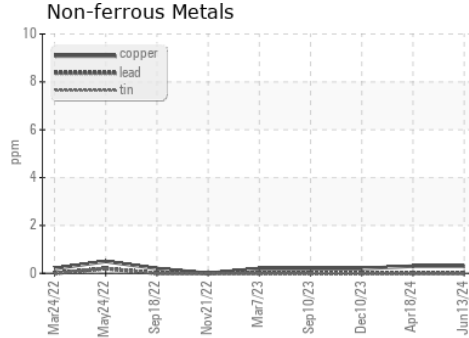
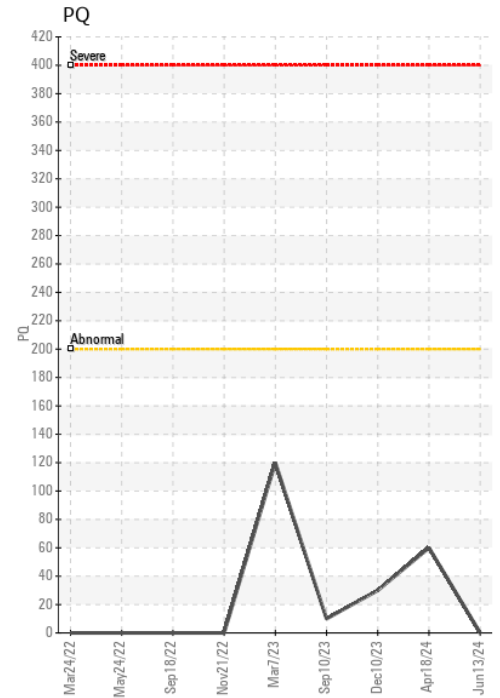
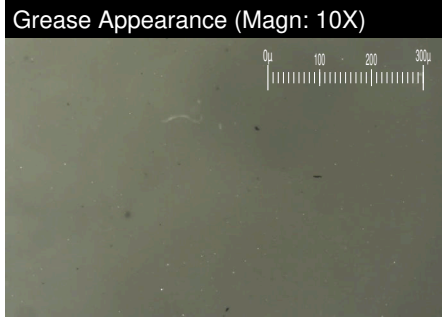
GRAPHS

method	limit/base	current	history1	history2
PQ	ASTM D8184* >200	0	60	30
Iron	ppm ASTM D5185(m) >250	29	16	18
Chromium	ppm ASTM D5185(m) >10	<1	0	0
Nickel	ppm ASTM D5185(m) >5	<1	<1	0
Cadmium	ppm ASTM D5185(m)	0	0	0
Titanium	ppm ASTM D5185(m)	<1	0	0
Vanadium	ppm ASTM D5185(m)	0	0	0
Lead	ppm ASTM D5185(m) >25	0	0	0
Copper	ppm ASTM D5185(m) >75	<1	<1	<1
Tin	ppm ASTM D5185(m) >5	0	0	0
Silver	ppm ASTM D5185(m) >5	<1	0	<1
