OIL ANALYSIS REPORT

EPIROC ST18 SCP202

Rear Differential

PENNZOIL SYNTHETIC SAE 75W140 GL-5 (--- GAL)

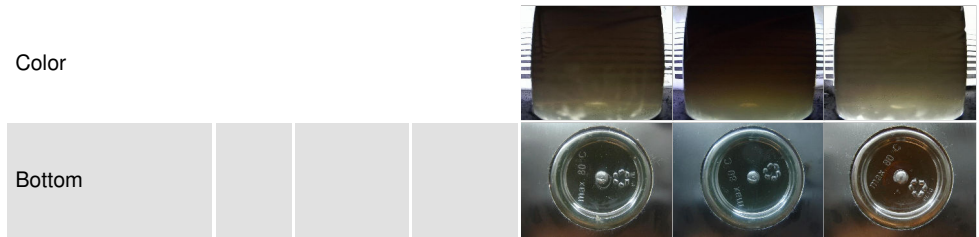
SAMPLE IMAGES	method	limit/base	current	history1	history2
---------------	--------	------------	---------	----------	----------

VISUAL	method	limit/base	current	history1	history2
White Metal	scalar	Visual*	NONE	NONE	NONE
Yellow Metal	scalar	Visual*	NONE	NONE	NONE
Precipitate	scalar	Visual*	NONE	NONE	NONE
Silt	scalar	Visual*	NONE	NONE	NONE
Debris	scalar	Visual*	NONE	NONE	NONE
Sand/Dirt	scalar	Visual*	NONE	NONE	NONE
Appearance	scalar	Visual*	NORML	NORML	NORML
Odor	scalar	Visual*	NORML	NORML	NORML
Emulsified Water	scalar	Visual*	>.2	NEG	NEG
Free Water	scalar	Visual*		NEG	NEG

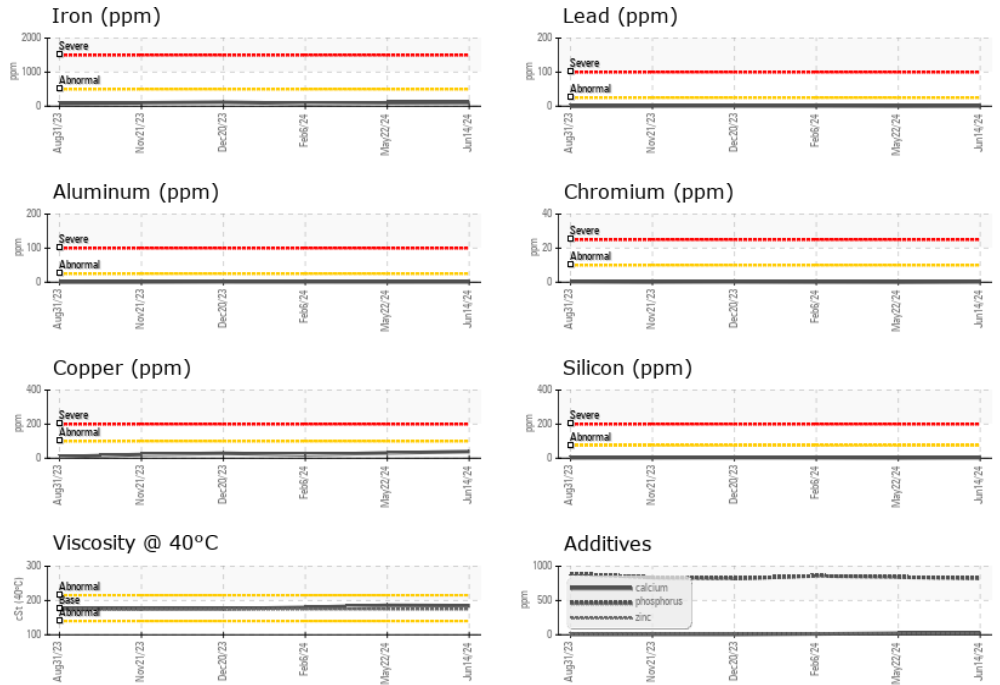
GRAPHS

All component wear rates are normal.

method	limit/base	current	history1	history2	
Iron	ppm	ASTM D5185(m)	>500	109	101	81
Chromium	ppm	ASTM D5185(m)	>10	<1	0	<1
Nickel	ppm	ASTM D5185(m)	>10	<1	0	<1
Titanium	ppm	ASTM D5185(m)		0	0	0
Silver	ppm	ASTM D5185(m)		0	0	0
Aluminum	ppm	ASTM D5185(m)	>25	<1	<1	1
Lead	ppm	ASTM D5185(m)	>25	<1	0	<1
Copper	ppm	ASTM D5185(m)	>100	39	31	21
Tin	ppm	ASTM D5185(m)	>10	<1	<1	<1
Antimony	ppm	ASTM D5185(m)	>5	<1	0	0
Vanadium	ppm	ASTM D5185(m)		0	0	0
Beryllium	ppm	ASTM D5185(m)		0	0	0
Cadmium	ppm	ASTM D5185(m)		0	0	0

Resample at the next service interval to monitor.
