OIL ANALYSIS REPORT

EPIROC ST18 SCP202

Rear Right Planetary

PENNZOIL SYNTHETIC SAE 75W140 GL-5 (--- GAL)

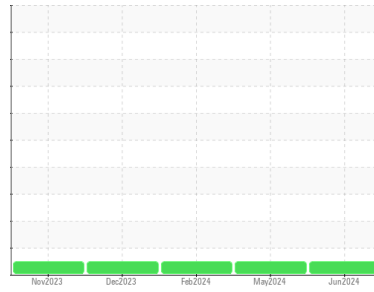
Sample Rating Trend

NORMAL

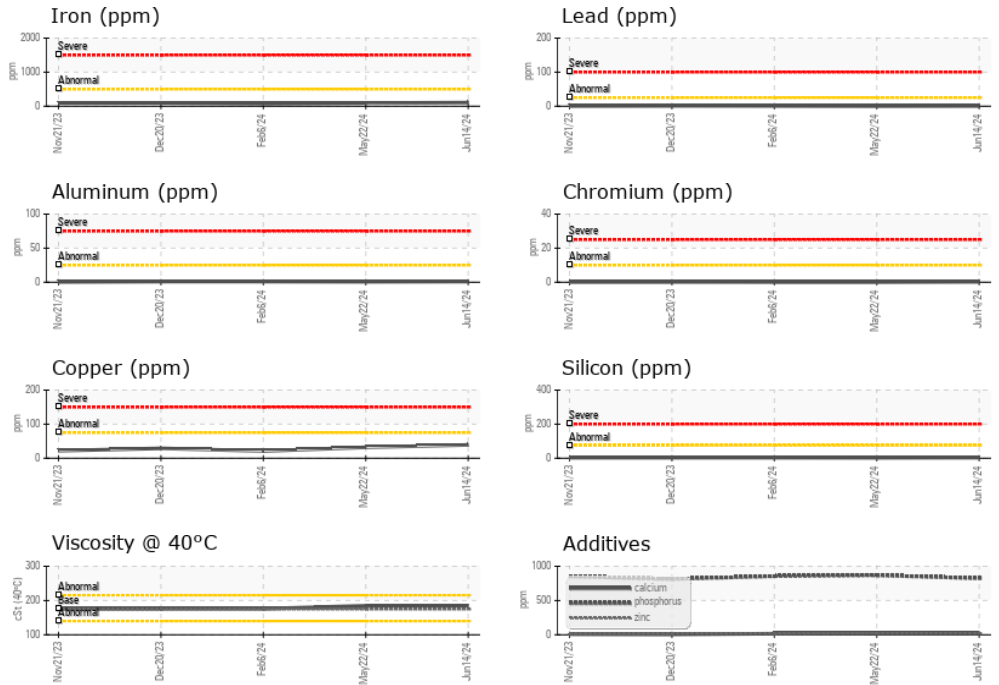
GRAPHS

All component wear rates are normal.

There is no indication of any contamination in the oil.

The condition of the oil is acceptable for the time in service.

Resample at the next service interval to monitor.
