OIL ANALYSIS REPORT

Machine Id
SL09
 Component
Rear Right Planetary
 Fluid
SAE 75W140 (--- GAL)

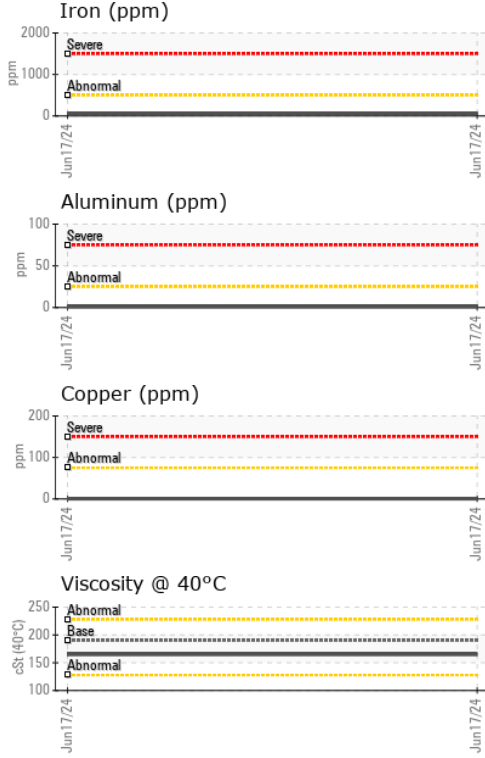
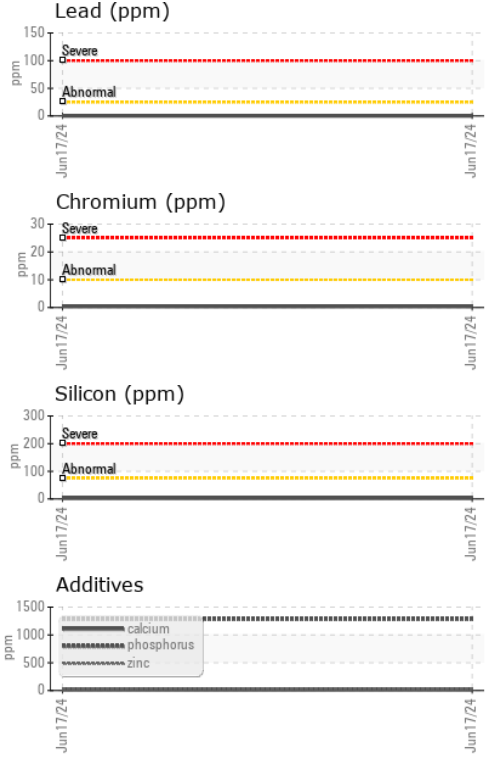
GRAPHS

All component wear rates are normal.

There is no indication of any contamination in the oil.

The condition of the oil is acceptable for the time in service.

Resample at the next service interval to monitor. Please specify the component make and model with your next sample.
