# OIL ANALYSIS REPORT

Machine Id  
**MPG B (S/N CAHE-V833200B)**  
 Component  
**Hydraulic System**  
 Fluid  
**MOBIL DTE 832 (--- LTR)**

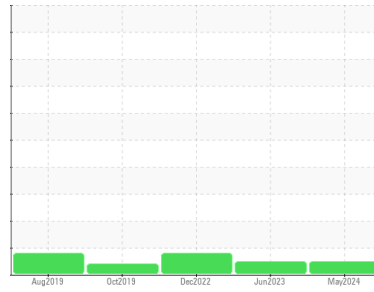
## Sample Rating Trend

**NORMAL**

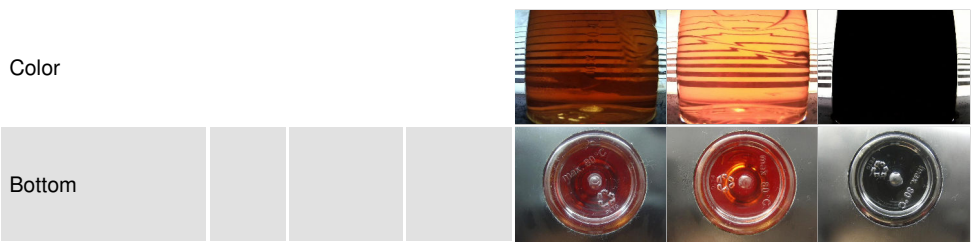
### SAMPLE IMAGES

VISUAL	method	limit/base	current	history1	history2
White Metal	scalar	Visual*	NONE	NONE	NONE
Yellow Metal	scalar	Visual*	NONE	NONE	NONE
Precipitate	scalar	Visual*	NONE	NONE	NONE
Silt	scalar	Visual*	NONE	NONE	NONE
Debris	scalar	Visual*	NONE	NONE	NONE
Sand/Dirt	scalar	Visual*	NONE	NONE	NONE
Appearance	scalar	Visual*	NORML	NORML	NORML
Odor	scalar	Visual*	NORML	NORML	NORML
Emulsified Water	scalar	Visual*	>0.05	NEG	NEG
Free Water	scalar	Visual*	NEG	NEG	NEG

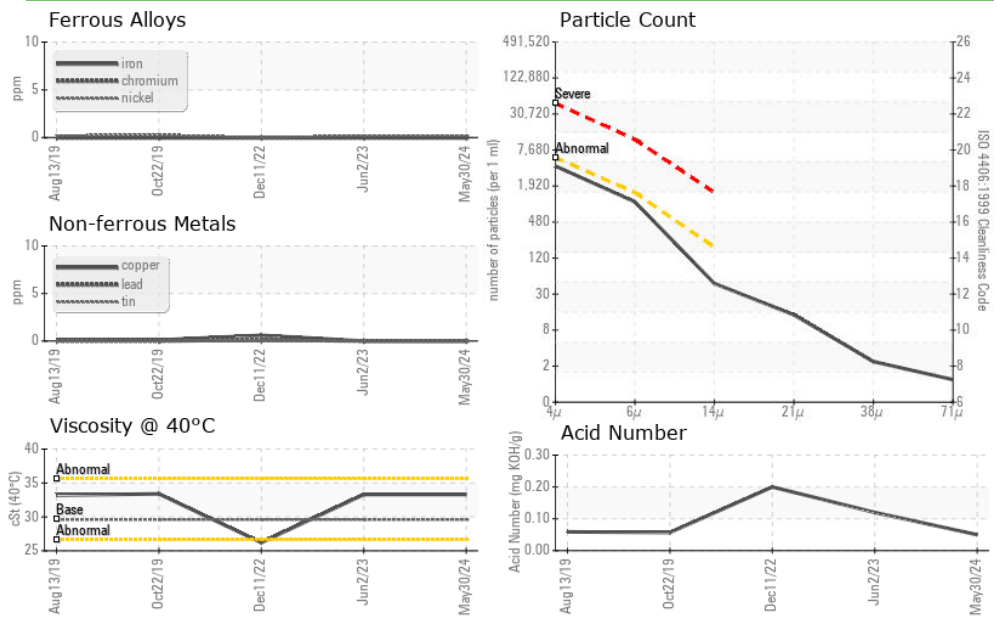
### GRAPHS

FLUID CLEANLINESS		method	limit/base	current	history1	history2
Particles >4µm		ASTM D7647	>5000	<b>3616</b>	3931	1261
Particles >6µm		ASTM D7647	>1300	<b>915</b>	640	171
Particles >14µm		ASTM D7647	>160	<b>40</b>	34	21
Particles >21µm		ASTM D7647	>40	<b>12</b>	9	12
Particles >38µm		ASTM D7647	>10	<b>2</b>	1	3
Particles >71µm		ASTM D7647	>3	<b>1</b>	0	1
Oil Cleanliness		ISO 4406 (c)	>19/17/14	<b>19/17/12</b>	19/16/12	17/15/12

FLUID DEGRADATION	method	limit/base	current	history1	history2
Acid Number (AN)	mg KOH/g	ASTM D974*	<b>0.05</b>	0.12	0.20

FLUID PROPERTIES	method	limit/base	current	history1	history2
Visc @ 40°C	cSt	ASTM D7279(m)	<b>33.3</b>	33.3	▲ 26.2

Resample at the next service interval to monitor.  
 NOTE: Please provide information regarding reservoir capacity, filter type and micron rating with next sample.
