# OIL ANALYSIS REPORT

**[C-GHHX] BOMBARDIER DHC-8-402 C-GHHX**

**Right Jet Turbine**

# FERROGRAPHY REPORT

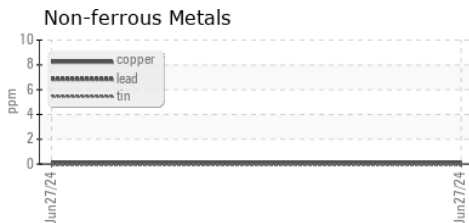
### GRAPHS

All component wear rates are normal. The ferrography results are normal indicating no abnormal wear in the system.

Resample at the next service interval to monitor. NOTE: Please provide information regarding reservoir capacity, filter type and micron rating with next sample. Please specify the brand, type, and viscosity of the oil on your next sample.
