OIL ANALYSIS REPORT

5042CD830R (S/N 8566805)

Hydraulic System

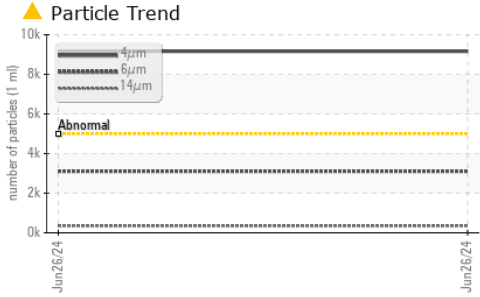
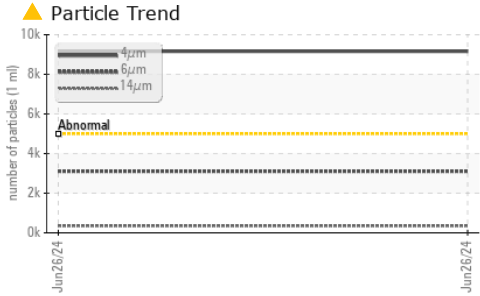
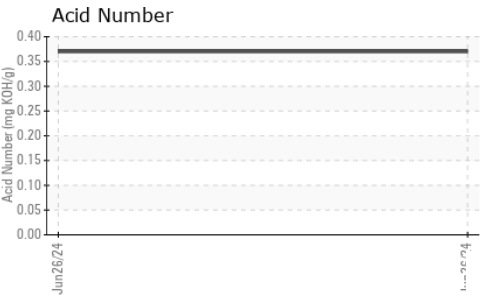
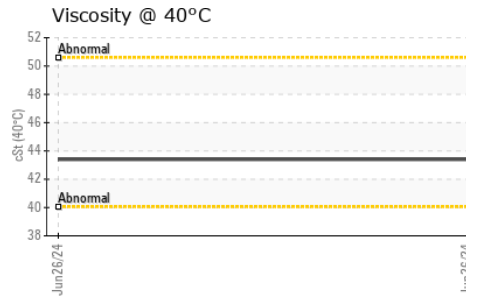
There is a moderate amount of particulates (2 to 100 microns in size) present in the oil.

FLUID CLEANLINESS		method	limit/base	current	history1	history2
Particles >4µm	ASTM D7647	>5000	● 9161	---	---	
Particles >6µm	ASTM D7647	>1300	▲ 3108	---	---	
Particles >14µm	ASTM D7647	>160	▲ 349	---	---	
Particles >21µm	ASTM D7647	>40	▲ 107	---	---	
Particles >38µm	ASTM D7647	>10	8	---	---	
Particles >71µm	ASTM D7647	>3	1	---	---	
Oil Cleanliness	ISO 4406 (c)	>19/17/14	▲ 20/19/16	---	---

Little or no information is provided as to the component and lubricant being tested. Recommendations are therefore generic in nature and may not apply to the current application. Please forward information as to equipment type, reservoir capacity, lubricant type and any pertinent information to allow for a more accurate assessment. We advise that you perform a filter service, and use off-line filtration to improve the cleanliness of the system fluid. We recommend an early resample to monitor this condition. NOTE: Please provide information regarding reservoir capacity, filter type and micron rating with next sample. Please specify the brand, type, and viscosity of the oil on your next sample.
