OIL ANALYSIS REPORT

Area
3 Calender Line
 Machine Id
42-0100 Feedmill
 Component
Gearbox
 Fluid
SUNOCO SUNE320 (100 LTR)

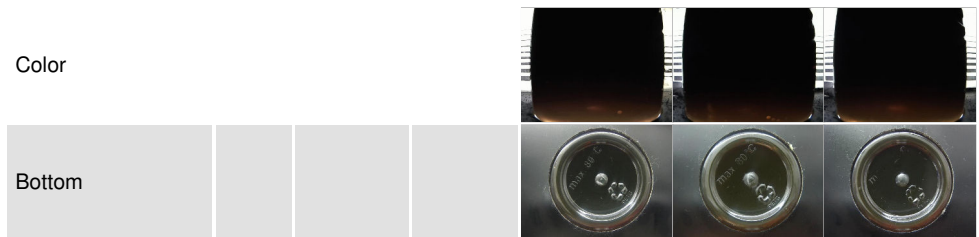
SAMPLE IMAGES	method	limit/base	current	history1	history2
---------------	--------	------------	---------	----------	----------

VISUAL	method	limit/base	current	history1	history2
White Metal	scalar	Visual*	NONE	VLITE	NONE
Yellow Metal	scalar	Visual*	NONE	NONE	NONE
Precipitate	scalar	Visual*	NONE	NONE	NONE
Silt	scalar	Visual*	NONE	NONE	NONE
Debris	scalar	Visual*	NONE	VLITE	NONE
Sand/Dirt	scalar	Visual*	NONE	NONE	NONE
Appearance	scalar	Visual*	NORML	NORML	NORML
Odor	scalar	Visual*	NORML	NORML	NORML
Emulsified Water	scalar	Visual*	>0.2	NEG	NEG
Free Water	scalar	Visual*		NEG	NEG

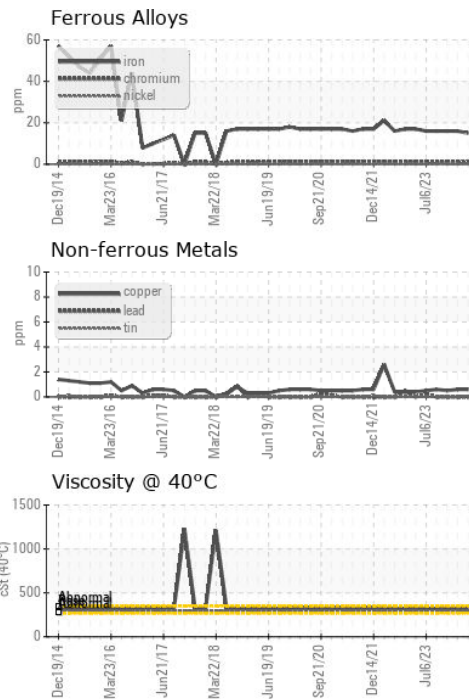
GRAPHS

All component wear rates are normal.

There is no indication of any contamination in the oil.

The condition of the oil is acceptable for the time in service.

Resample at the next service interval to monitor.
