OIL ANALYSIS REPORT

Area
3 Calender Line
 Machine Id
42-0384 Banbury
 Component
Gearbox
 Fluid
SUNOCO SUNE320 (51 GAL)

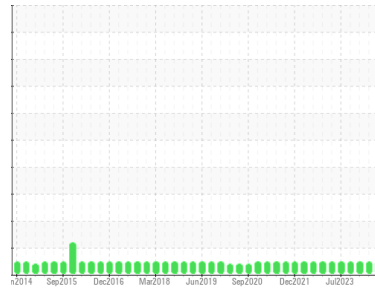
Sample Rating Trend

NORMAL

All component wear rates are normal.

There is no indication of any contamination in the oil.

The condition of the oil is acceptable for the time in service.

Resample at the next service interval to monitor.

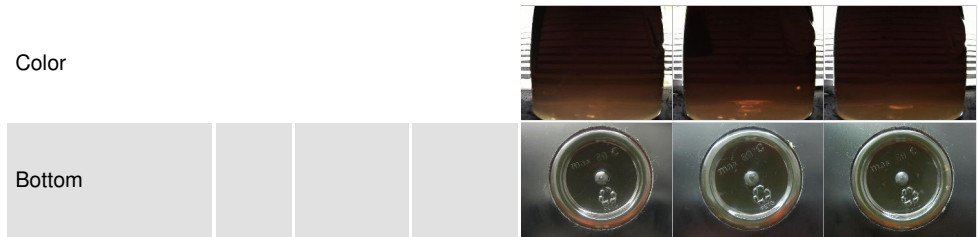
SAMPLE IMAGES	method	limit/base	current	history1	history2
---------------	--------	------------	---------	----------	----------

VISUAL	method	limit/base	current	history1	history2
White Metal	scalar	Visual*	NONE	NONE	NONE
Yellow Metal	scalar	Visual*	NONE	NONE	NONE
Precipitate	scalar	Visual*	NONE	NONE	NONE
Silt	scalar	Visual*	NONE	NONE	NONE
Debris	scalar	Visual*	NONE	NONE	VLITE
Sand/Dirt	scalar	Visual*	NONE	NONE	NONE
Appearance	scalar	Visual*	NORML	NORML	NORML
Odor	scalar	Visual*	NORML	NORML	NORML
Emulsified Water	scalar	Visual*	>0.2	NEG	NEG
Free Water	scalar	Visual*		NEG	NEG

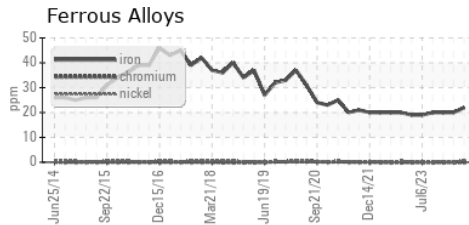
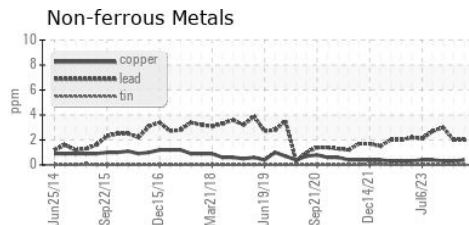
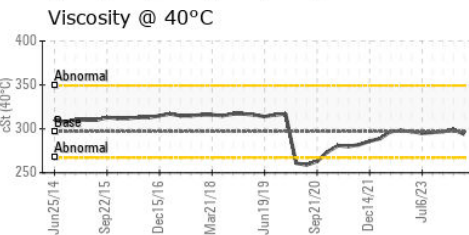
GRAPHS

method	limit/base	current	history1	history2	
Iron	ppm	ASTM D5185(m)	>200	22	20	20
Chromium	ppm	ASTM D5185(m)	>15	0	0	0
Nickel	ppm	ASTM D5185(m)	>15	<1	0	<1
Titanium	ppm	ASTM D5185(m)		0	0	0
Silver	ppm	ASTM D5185(m)		0	0	0
Aluminum	ppm	ASTM D5185(m)	>25	<1	0	<1
Lead	ppm	ASTM D5185(m)	>100	2	2	3
Copper	ppm	ASTM D5185(m)	>200	<1	<1	<1
Tin	ppm	ASTM D5185(m)	>25	0	0	0
Antimony	ppm	ASTM D5185(m)	>5	0	0	0
Vanadium	ppm	ASTM D5185(m)		0	0	0
Beryllium	ppm	ASTM D5185(m)		0	0	0
Cadmium	ppm	ASTM D5185(m)		0	0	0

FLUID PROPERTIES	method	limit/base	current	history1	history2
Visc @ 40°C	cSt	ASTM D7279(m)	297	294	299
