OIL ANALYSIS REPORT

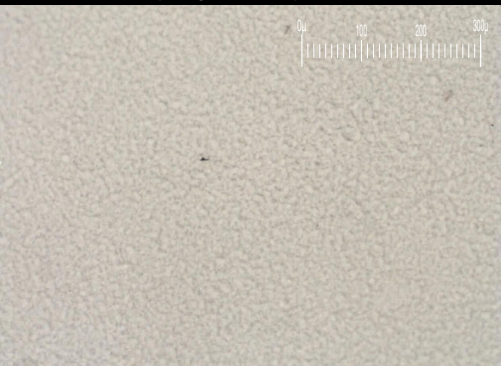
Particle Filter (Magn: 100 x)

The system cleanliness is acceptable for your target ISO 4406 cleanliness code. The system and fluid cleanliness is acceptable.

Resample at the next service interval to monitor.

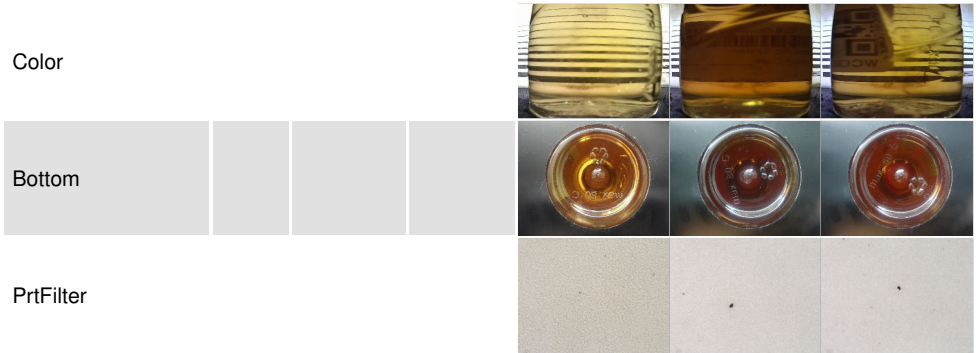
| SAMPLE IMAGES | method | limit/base | current | history1 | history2 |

| VISUAL | method | limit/base | current | history1 | history2 | |
|---|---|---|---|---|---|---|
| Appearance | scalar | Visual* | NORML | NORML | NORML | NORML |
