OIL ANALYSIS REPORT

Machine Id
ATLAS COPCO ST7 SCP209
 Component
Rear Differential
 Fluid
GEAR OIL SAE 75W140 (--- GAL)

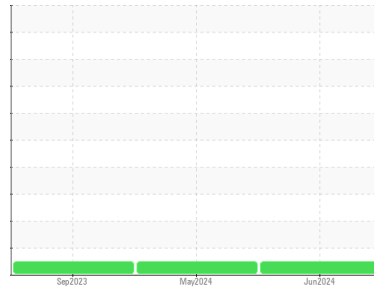
Sample Rating Trend

NORMAL

All component wear rates are normal.

There is no indication of any contamination in the oil.

The condition of the oil is acceptable for the time in service.

Resample at the next service interval to monitor.

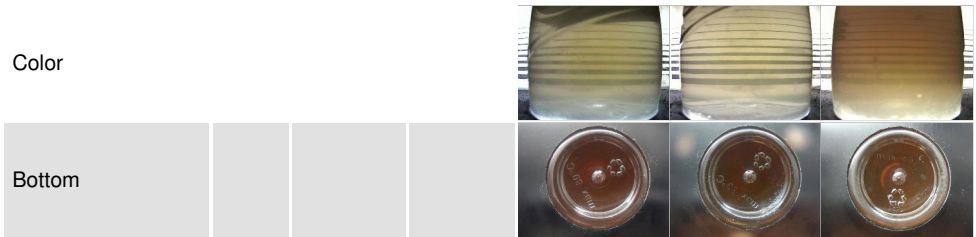
SAMPLE IMAGES	method	limit/base	current	history1	history2
---------------	--------	------------	---------	----------	----------

VISUAL	method	limit/base	current	history1	history2
White Metal	scalar	Visual*	NONE	VLITE	NONE
Yellow Metal	scalar	Visual*	NONE	NONE	VLITE
Precipitate	scalar	Visual*	NONE	NONE	NONE
Silt	scalar	Visual*	NONE	NONE	NONE
Debris	scalar	Visual*	NONE	NONE	VLITE
Sand/Dirt	scalar	Visual*	NONE	VLITE	NONE
Appearance	scalar	Visual*	NORML	NORML	NORML
Odor	scalar	Visual*	NORML	NORML	NORML
Emulsified Water	scalar	Visual*	>.2	NEG	NEG
Free Water	scalar	Visual*		NEG	NEG
