OIL ANALYSIS REPORT

Machine Id
EPIROC MT65 TRK220
 Component
Front Differential
 Fluid
GEAR OIL SAE 75W140 (--- GAL)

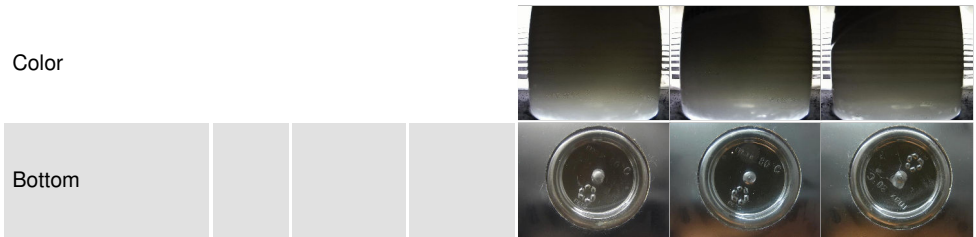
SAMPLE IMAGES	method	limit/base	current	history1	history2
---------------	--------	------------	---------	----------	----------

VISUAL	method	limit/base	current	history1	history2	
White Metal	scalar	Visual*	NONE	VLITE	NONE	LIGHT
Yellow Metal	scalar	Visual*	NONE	NONE	NONE	NONE
Precipitate	scalar	Visual*	NONE	NONE	NONE	NONE
Silt	scalar	Visual*	NONE	NONE	NONE	VLITE
Debris	scalar	Visual*	NONE	VLITE	VLITE	NONE
Sand/Dirt	scalar	Visual*	NONE	VLITE	NONE	NONE
Appearance	scalar	Visual*	NORML	NORML	NORML	NORML
Odor	scalar	Visual*	NORML	NORML	NORML	NORML
Emulsified Water	scalar	Visual*	>.2	NEG	NEG	NEG
Free Water	scalar	Visual*		NEG	NEG	NEG

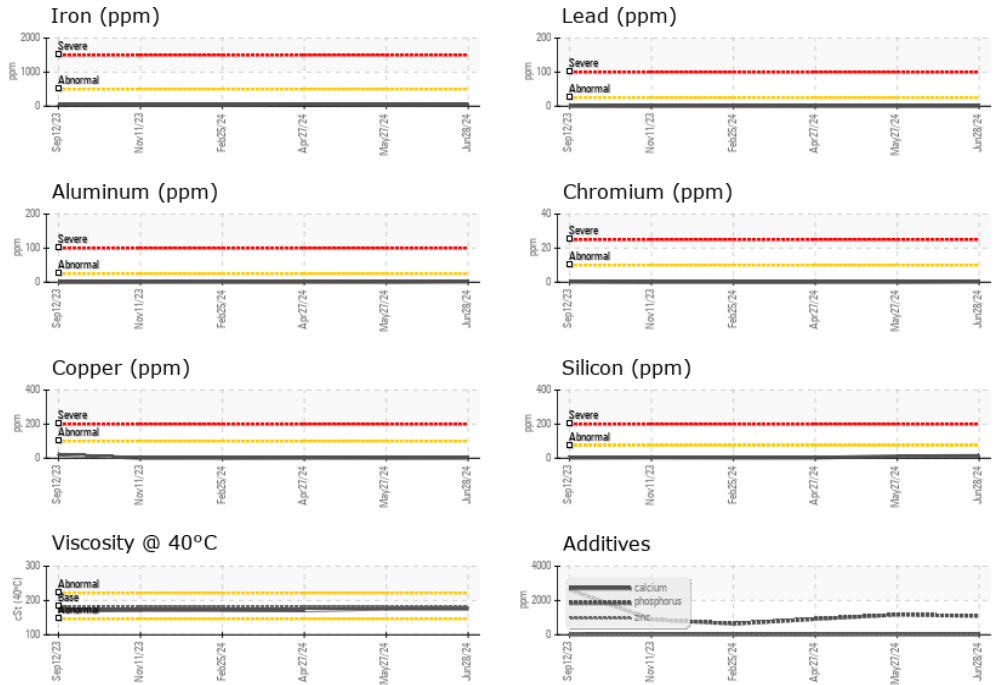
GRAPHS

WEAR METALS		method	limit/base	current	history1	history2
Iron	ppm	ASTM D5185(m)	>500	48	38	62
Chromium	ppm	ASTM D5185(m)	>10	<1	0	0
Nickel	ppm	ASTM D5185(m)	>10	<1	0	0
Titanium	ppm	ASTM D5185(m)		0	0	0
Silver	ppm	ASTM D5185(m)		0	0	0
Aluminum	ppm	ASTM D5185(m)	>25	1	0	<1
Lead	ppm	ASTM D5185(m)	>25	0	0	0
Copper	ppm	ASTM D5185(m)	>100	1	<1	2
Tin	ppm	ASTM D5185(m)	>10	0	0	0
Antimony	ppm	ASTM D5185(m)	>5	0	0	0
Vanadium	ppm	ASTM D5185(m)		0	0	0
Beryllium	ppm	ASTM D5185(m)		0	0	0
Cadmium	ppm	ASTM D5185(m)		0	0	0

FLUID PROPERTIES	method	limit/base	current	history1	history2	
Visc @ 40°C	cSt	ASTM D7279(m)	183	176	176	171

Resample at the next service interval to monitor.
