OIL ANALYSIS REPORT

Machine Id
EPIROC MT65 TRK220
 Component
Front Left Planetary
 Fluid
SAE 75W140 (--- GAL)

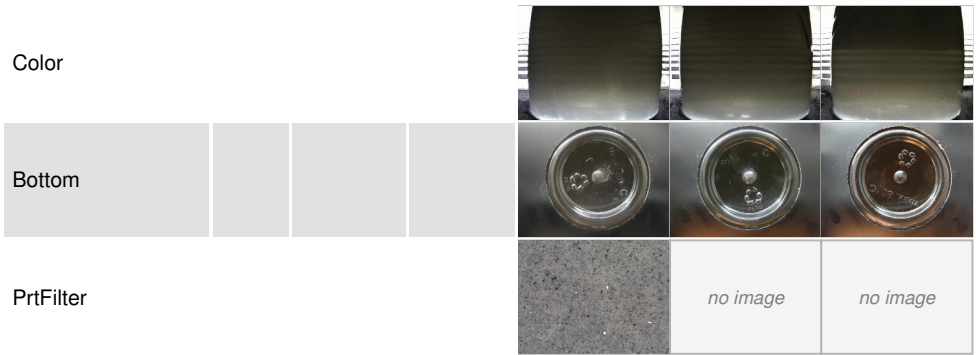
SAMPLE IMAGES	method	limit/base	current	history1	history2
---------------	--------	------------	---------	----------	----------

VISUAL	method	limit/base	current	history1	history2
White Metal	scalar	Visual*	NONE	VLITE	NONE
Yellow Metal	scalar	Visual*	NONE	NONE	NONE
Precipitate	scalar	Visual*	NONE	NONE	NONE
Silt	scalar	Visual*	NONE	VLITE	NONE
Debris	scalar	Visual*	NONE	NONE	NONE
Sand/Dirt	scalar	Visual*	NONE	NONE	NONE
Appearance	scalar	Visual*	NORML	NORML	NORML
Odor	scalar	Visual*	NORML	NORML	NORML
Emulsified Water	scalar	Visual*	>0.2	NEG	NEG
Free Water	scalar	Visual*		NEG	NEG

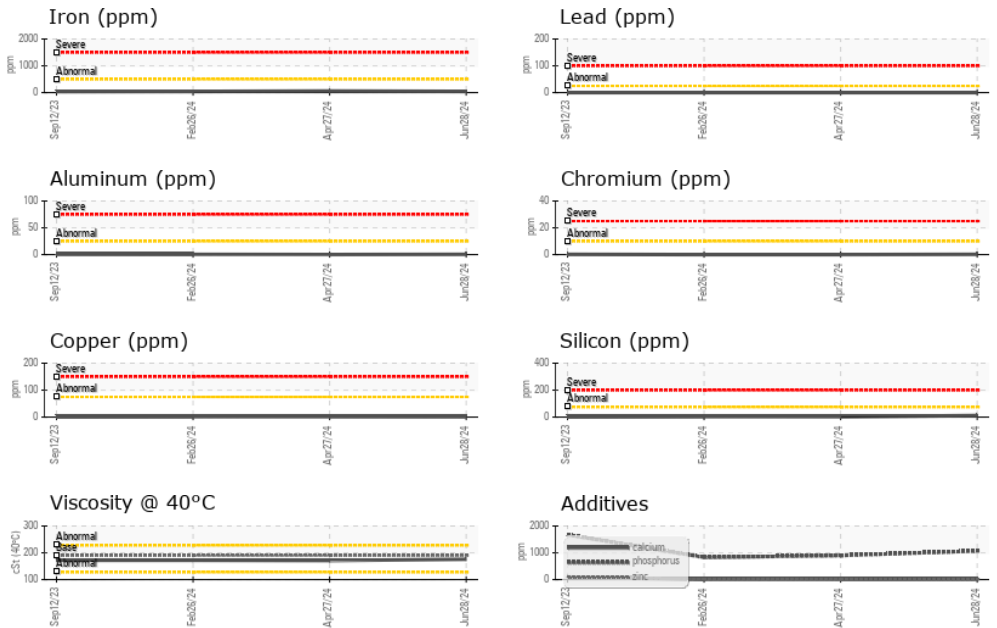
GRAPHS

WEAR METALS		method	limit/base	current	history1	history2
Iron	ppm	ASTM D5185(m)	>500	46	60	45
Chromium	ppm	ASTM D5185(m)	>10	<1	0	0
Nickel	ppm	ASTM D5185(m)	>10	<1	0	<1
Titanium	ppm	ASTM D5185(m)		0	0	0
Silver	ppm	ASTM D5185(m)		0	0	0
Aluminum	ppm	ASTM D5185(m)	>25	<1	<1	<1
Lead	ppm	ASTM D5185(m)	>25	0	0	0
Copper	ppm	ASTM D5185(m)	>75	1	1	1
Tin	ppm	ASTM D5185(m)	>10	0	0	0
Antimony	ppm	ASTM D5185(m)	>5	0	0	0
Vanadium	ppm	ASTM D5185(m)		0	0	0
Beryllium	ppm	ASTM D5185(m)		0	0	0
Cadmium	ppm	ASTM D5185(m)		0	0	0

Resample at the next service interval to monitor.
