OIL ANALYSIS REPORT

Machine Id
EPIROC ST18 SCP203
 Component
Front Left Planetary
 Fluid
GEAR OIL SAE 75W140 (--- GAL)

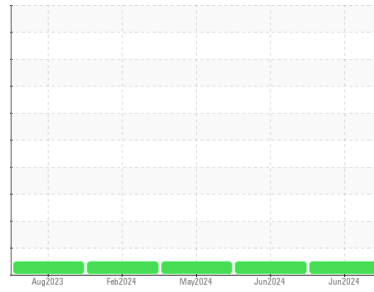
Sample Rating Trend

NORMAL

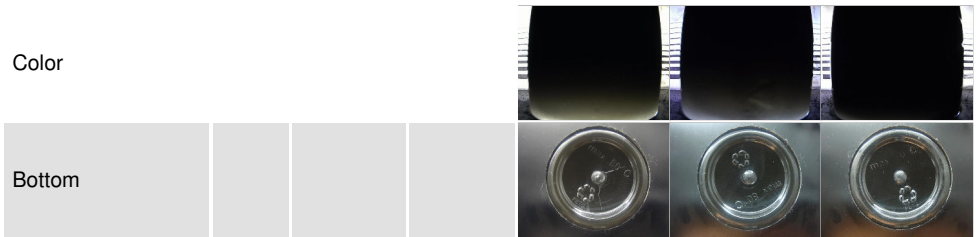
SAMPLE IMAGES	method	limit/base	current	history1	history2
---------------	--------	------------	---------	----------	----------

VISUAL	method	limit/base	current	history1	history2
White Metal	scalar	Visual*	NONE	VLITE	NONE
Yellow Metal	scalar	Visual*	NONE	NONE	NONE
Precipitate	scalar	Visual*	NONE	NONE	NONE
Silt	scalar	Visual*	NONE	NONE	VLITE
Debris	scalar	Visual*	NONE	NONE	NONE
Sand/Dirt	scalar	Visual*	NONE	NONE	NONE
Appearance	scalar	Visual*	NORML	NORML	NORML
Odor	scalar	Visual*	NORML	NORML	NORML
Emulsified Water	scalar	Visual*	>0.2	NEG	NEG
Free Water	scalar	Visual*		NEG	NEG

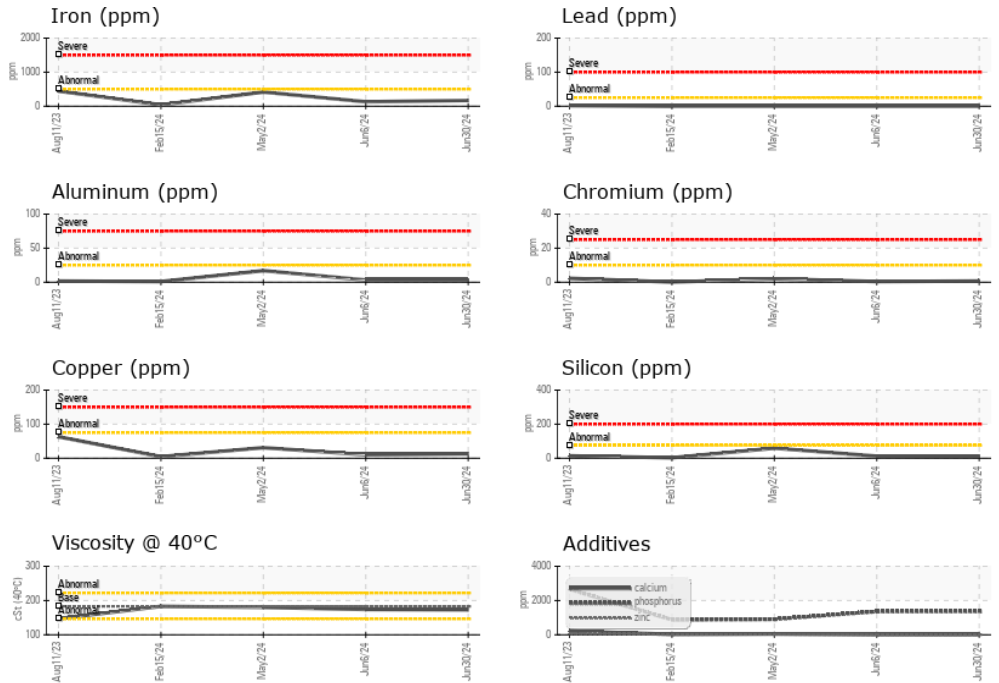
GRAPHS

All component wear rates are normal.

There is no indication of any contamination in the oil.

The condition of the oil is acceptable for the time in service.

Resample at the next service interval to monitor.
