OIL ANALYSIS REPORT

Machine Id
EPIROC ST18 SCP203
 Component
Rear Left Planetary
 Fluid
GEAR OIL SAE 75W140 (--- GAL)

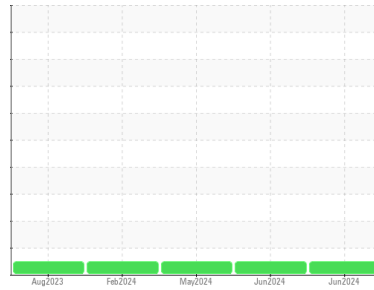
Sample Rating Trend

NORMAL

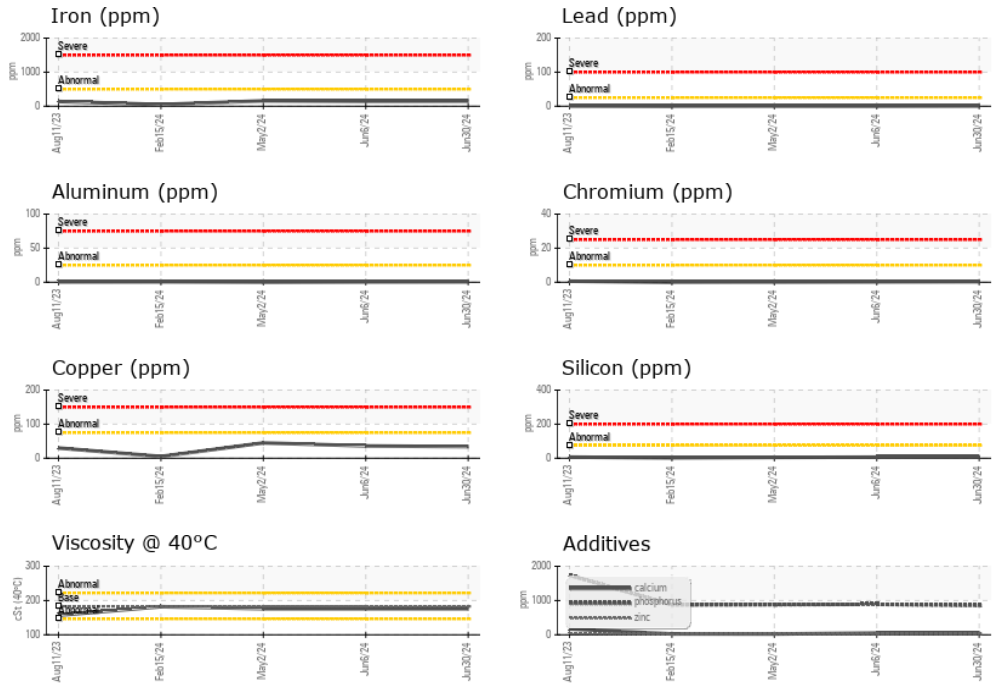
GRAPHS

All component wear rates are normal.

There is no indication of any contamination in the oil.

The condition of the oil is acceptable for the time in service.

Resample at the next service interval to monitor.
