OIL ANALYSIS REPORT

Machine Id
EPIROC ST18 SCP203
 Component
Front Right Planetary
 Fluid
GEAR OIL SAE 75W140 (--- GAL)

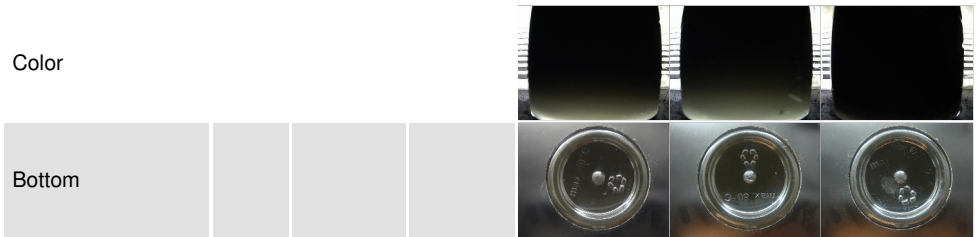
SAMPLE IMAGES	method	limit/base	current	history1	history2
---------------	--------	------------	---------	----------	----------

VISUAL	method	limit/base	current	history1	history2	
White Metal	scalar	Visual*	NONE	VLITE	NONE	NONE
Yellow Metal	scalar	Visual*	NONE	NONE	NONE	NONE
Precipitate	scalar	Visual*	NONE	NONE	NONE	NONE
Silt	scalar	Visual*	NONE	VLITE	NONE	NONE
Debris	scalar	Visual*	NONE	NONE	NONE	NONE
Sand/Dirt	scalar	Visual*	NONE	NONE	NONE	NONE
Appearance	scalar	Visual*	NORML	NORML	NORML	NORML
Odor	scalar	Visual*	NORML	NORML	NORML	NORML
Emulsified Water	scalar	Visual*	>0.2	NEG	NEG	NEG
Free Water	scalar	Visual*		NEG	NEG	NEG

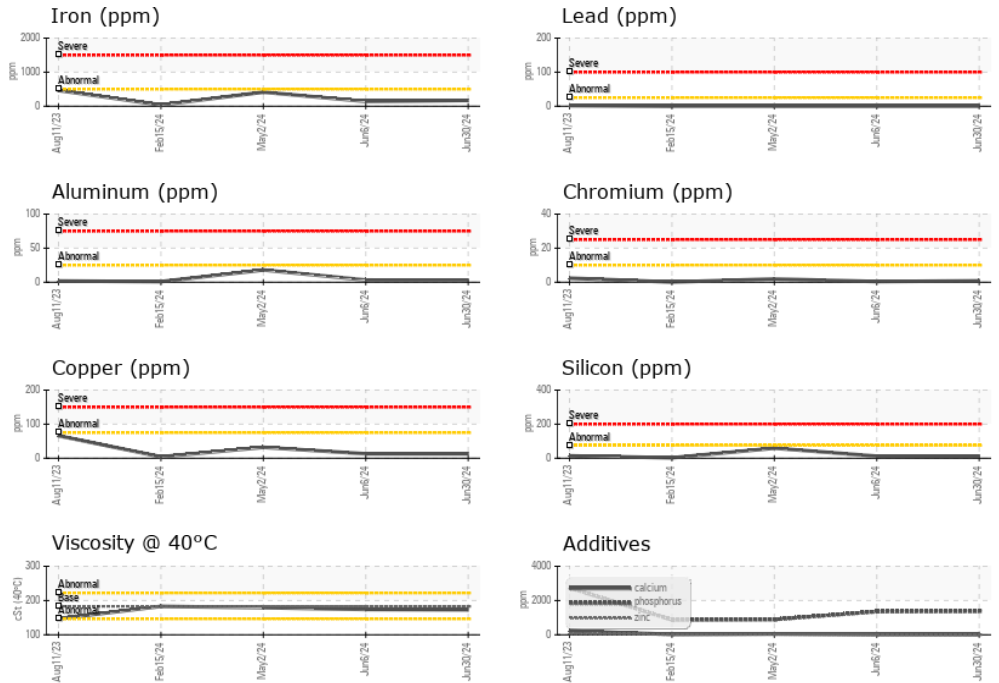
GRAPHS

All component wear rates are normal.

WEAR METALS		method	limit/base	current	history1	history2
Iron	ppm	ASTM D5185(m)	>500	170	140	413
Chromium	ppm	ASTM D5185(m)	>10	<1	<1	2
Nickel	ppm	ASTM D5185(m)	>10	<1	<1	<1
Titanium	ppm	ASTM D5185(m)		<1	<1	1
Silver	ppm	ASTM D5185(m)		1	0	0
Aluminum	ppm	ASTM D5185(m)	>25	3	3	18
Lead	ppm	ASTM D5185(m)	>25	0	0	0
Copper	ppm	ASTM D5185(m)	>75	13	13	32
Tin	ppm	ASTM D5185(m)	>10	<1	<1	1
Antimony	ppm	ASTM D5185(m)	>5	0	0	0
Vanadium	ppm	ASTM D5185(m)		0	0	0
Beryllium	ppm	ASTM D5185(m)		0	0	0
Cadmium	ppm	ASTM D5185(m)		0	0	0

Resample at the next service interval to monitor.
