OIL ANALYSIS REPORT

Goodyear - G04000

Machine Id
A2407030

Component
Hydraulic System

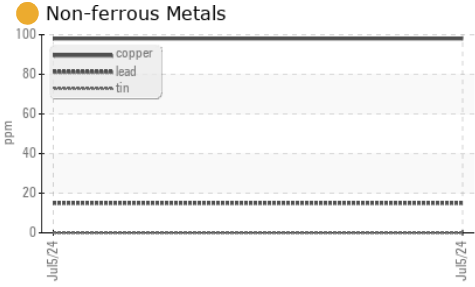
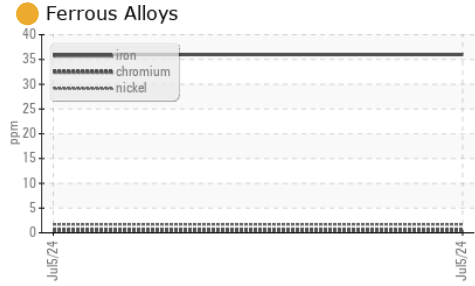
GRAPHS

- **Wear**
Copper and iron ppm levels are noted.

WEAR METALS		method	limit/base	current	history1	history2
Iron	ppm	ASTM D5185(m)	>20	● 36	---	---
Chromium	ppm	ASTM D5185(m)	>10	<1	---	---
Nickel	ppm	ASTM D5185(m)	>10	2	---	---
Titanium	ppm	ASTM D5185(m)		0	---	---
Silver	ppm	ASTM D5185(m)		<1	---	---
Aluminum	ppm	ASTM D5185(m)	>10	4	---	---
Lead	ppm	ASTM D5185(m)	>20	15	---	---
Copper	ppm	ASTM D5185(m)	>20	● 98	---	---
Tin	ppm	ASTM D5185(m)	>10	0	---	---
Antimony	ppm	ASTM D5185(m)		0	---	---
Vanadium	ppm	ASTM D5185(m)		0	---	---
Beryllium	ppm	ASTM D5185(m)		0	---	---
Cadmium	ppm	ASTM D5185(m)		1	---	---
