OIL ANALYSIS REPORT

[C-FKFJ] BEEHCRAFT KING AIR B200 C-FKFJ

Left Jet Turbine

BP TURBO OIL 2380 (--- LTR)

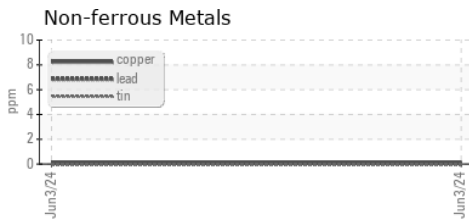
GRAPHS

All component wear rates are normal. The ferrography results are normal indicating no abnormal wear in the system.

The water content is negligible. There is no indication of any contamination in the oil.

The AN level is acceptable for this fluid. The condition of the oil is suitable for further service.

Resample at the next service interval to monitor. NOTE: Please provide information regarding reservoir capacity, filter type and micron rating with next sample.
