OIL ANALYSIS REPORT

Machine Id
CATERPILLAR R1600 SCP219
 Component
Rear Left Planetary
 Fluid
PETRO CANADA PRODURO TO-4 SAE 50 (--- GAL)

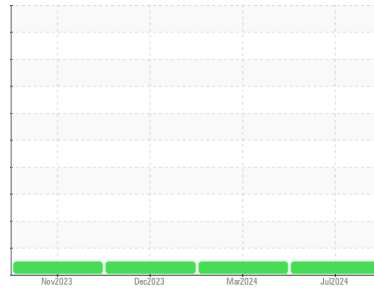
Sample Rating Trend

NORMAL

All component wear rates are normal.

There is no indication of any contamination in the oil.

The condition of the oil is acceptable for the time in service.

Resample at the next service interval to monitor.

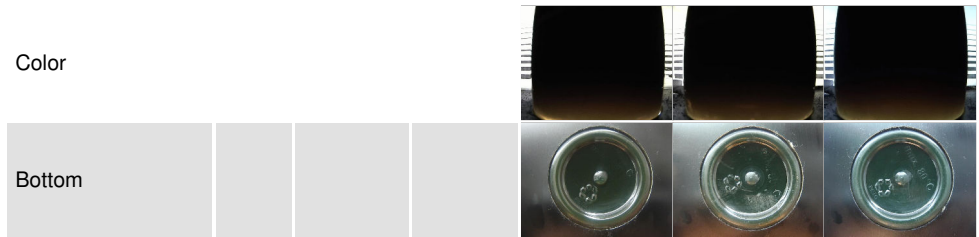
SAMPLE IMAGES	method	limit/base	current	history1	history2
---------------	--------	------------	---------	----------	----------

VISUAL	method	limit/base	current	history1	history2
White Metal	scalar	Visual*	NONE	NONE	NONE
Yellow Metal	scalar	Visual*	NONE	NONE	NONE
Precipitate	scalar	Visual*	NONE	NONE	NONE
Silt	scalar	Visual*	NONE	NONE	NONE
Debris	scalar	Visual*	NONE	NONE	NONE
Sand/Dirt	scalar	Visual*	NONE	NONE	NONE
Appearance	scalar	Visual*	NORML	NORML	NORML
Odor	scalar	Visual*	NORML	NORML	NORML
Emulsified Water	scalar	Visual*	>0.2	NEG	NEG
Free Water	scalar	Visual*		NEG	NEG
