OIL ANALYSIS REPORT

Machine Id
CATERPILLAR R1600 SCP219
 Component
Rear Right Planetary
 Fluid
PETRO CANADA PRODURO TO-4 SAE 50 (--- GAL)

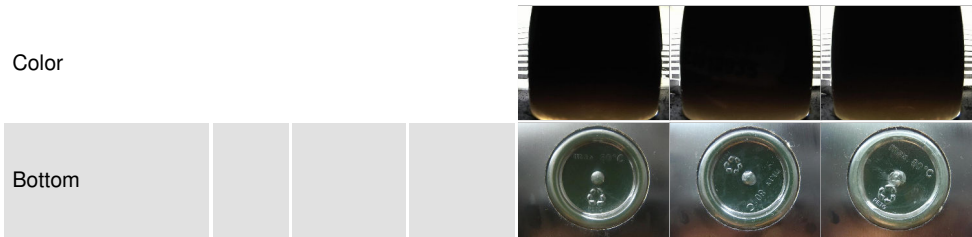
SAMPLE IMAGES	method	limit/base	current	history1	history2
---------------	--------	------------	---------	----------	----------

VISUAL	method	limit/base	current	history1	history2
White Metal	scalar	Visual*	NONE	NONE	NONE
Yellow Metal	scalar	Visual*	NONE	NONE	NONE
Precipitate	scalar	Visual*	NONE	NONE	NONE
Silt	scalar	Visual*	NONE	NONE	NONE
Debris	scalar	Visual*	NONE	NONE	NONE
Sand/Dirt	scalar	Visual*	NONE	NONE	NONE
Appearance	scalar	Visual*	NORML	NORML	NORML
Odor	scalar	Visual*	NORML	NORML	NORML
Emulsified Water	scalar	Visual*	>0.2	NEG	NEG
Free Water	scalar	Visual*		NEG	NEG

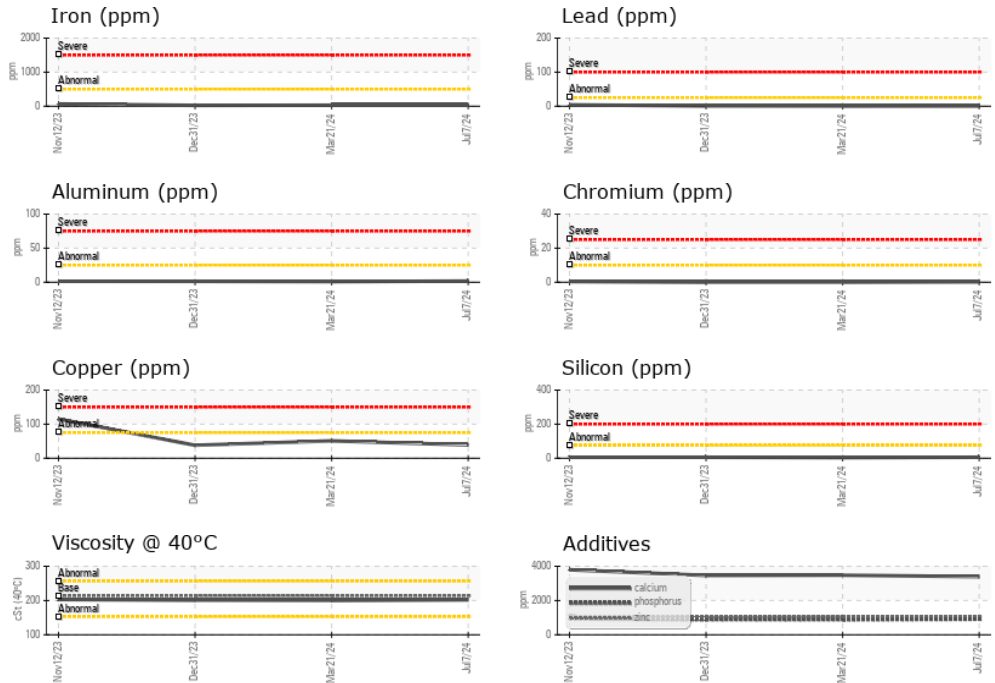
GRAPHS

All component wear rates are normal.

There is no indication of any contamination in the oil.

The condition of the oil is acceptable for the time in service.

Resample at the next service interval to monitor.
