OIL ANALYSIS REPORT

Machine Id
CATERPILLAR R1600H SCP222
 Component
Front Differential
 Fluid
PETRO CANADA PRODURO TO-4 SAE 50 (--- GAL)

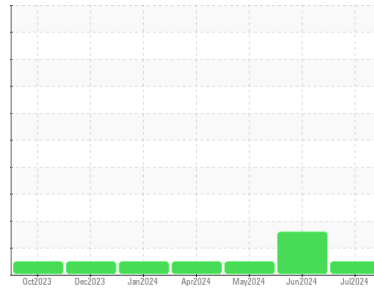
Sample Rating Trend

NORMAL

All component wear rates are normal.

There is no indication of any contamination in the oil.

The condition of the oil is acceptable for the time in service.

Resample at the next service interval to monitor.
