OIL ANALYSIS REPORT

Machine Id
CATERPILLAR R1600G SCP215
 Component
Rear Right Planetary
 Fluid
PETRO CANADA PRODURO TO-4 SAE 50 (--- GAL)

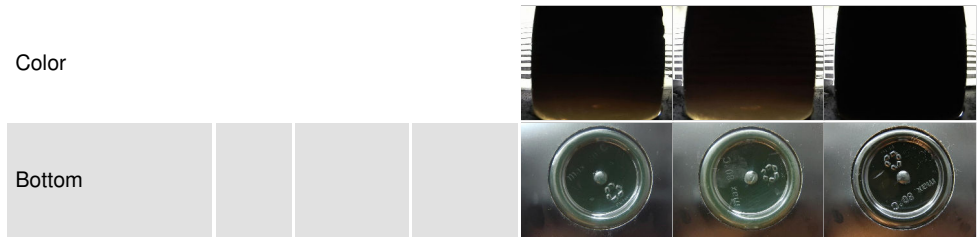
SAMPLE IMAGES	method	limit/base	current	history1	history2
---------------	--------	------------	---------	----------	----------

VISUAL	method	limit/base	current	history1	history2	
White Metal	scalar	Visual*	NONE	LIGHT	NONE	NONE
Yellow Metal	scalar	Visual*	NONE	NONE	NONE	NONE
Precipitate	scalar	Visual*	NONE	NONE	NONE	NONE
Silt	scalar	Visual*	NONE	NONE	NONE	NONE
Debris	scalar	Visual*	NONE	NONE	NONE	NONE
Sand/Dirt	scalar	Visual*	NONE	NONE	NONE	NONE
Appearance	scalar	Visual*	NORML	NORML	NORML	NORML
Odor	scalar	Visual*	NORML	NORML	NORML	NORML
Emulsified Water	scalar	Visual*	>0.2	NEG	NEG	NEG
Free Water	scalar	Visual*		NEG	NEG	NEG

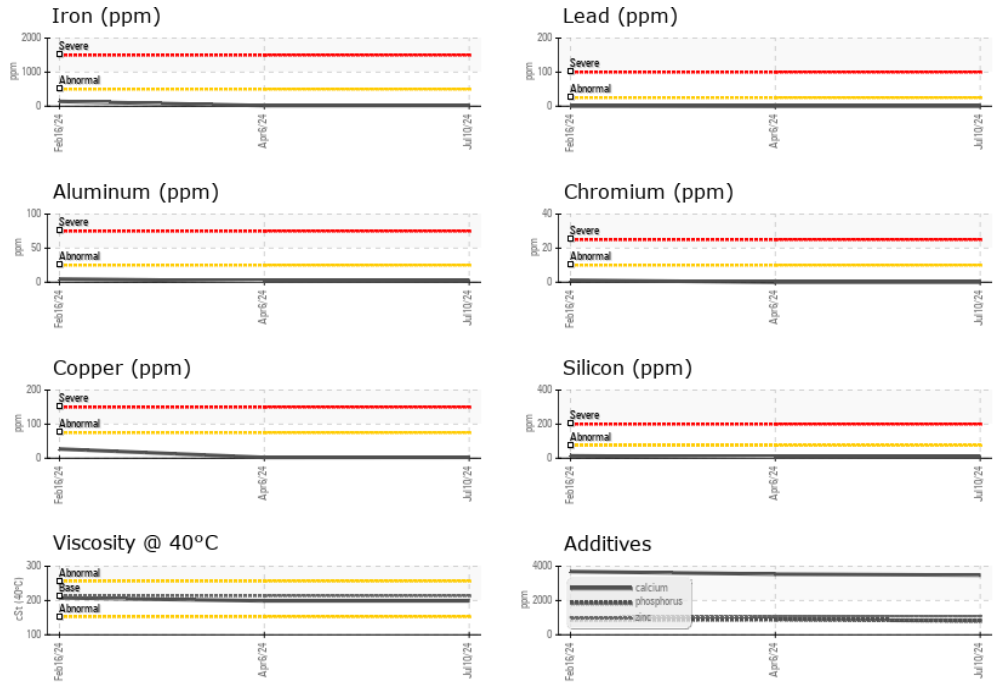
GRAPHS

All component wear rates are normal.

There is no indication of any contamination in the oil.

The condition of the oil is acceptable for the time in service.

Resample at the next service interval to monitor.
