OIL ANALYSIS REPORT

Machine Id
CATERPILLAR R1600G SCP215
 Component
Front Right Planetary
 Fluid
PETRO CANADA PRODURO TO-4 SAE 50 (--- GAL)

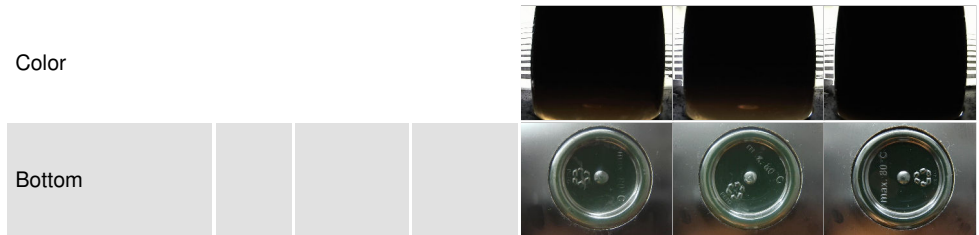
SAMPLE IMAGES	method	limit/base	current	history1	history2
---------------	--------	------------	---------	----------	----------

VISUAL	method	limit/base	current	history1	history2	
White Metal	scalar	Visual*	NONE	VLITE	NONE	NONE
Yellow Metal	scalar	Visual*	NONE	NONE	NONE	NONE
Precipitate	scalar	Visual*	NONE	NONE	NONE	NONE
Silt	scalar	Visual*	NONE	NONE	NONE	NONE
Debris	scalar	Visual*	NONE	NONE	NONE	NONE
Sand/Dirt	scalar	Visual*	NONE	NONE	NONE	NONE
Appearance	scalar	Visual*	NORML	NORML	NORML	NORML
Odor	scalar	Visual*	NORML	NORML	NORML	NORML
Emulsified Water	scalar	Visual*	>0.2	NEG	NEG	NEG
Free Water	scalar	Visual*		NEG	NEG	NEG

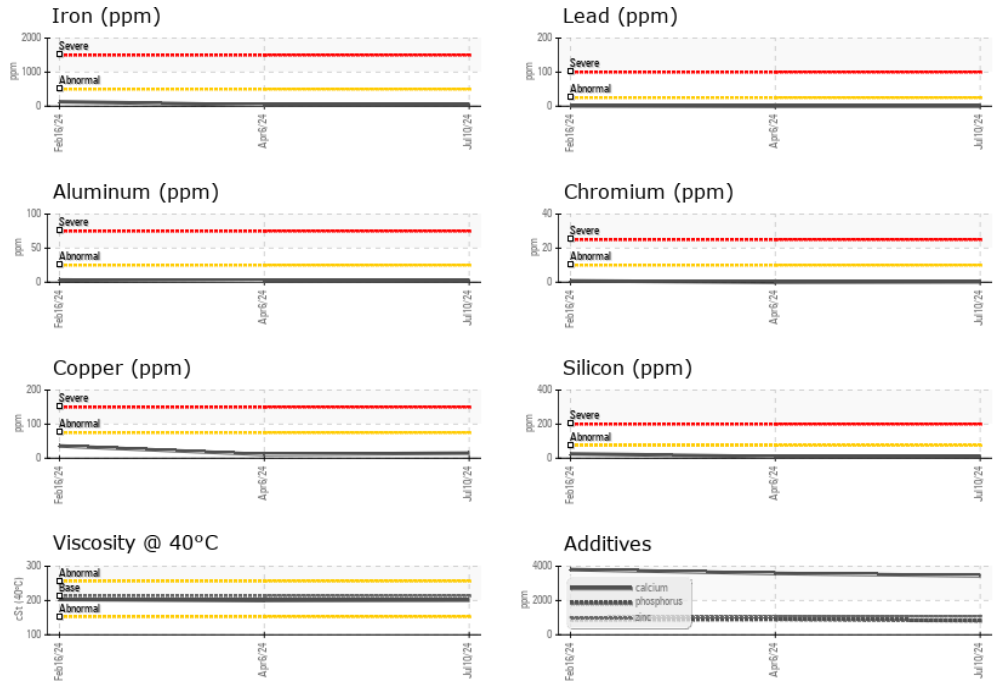
GRAPHS

All component wear rates are normal.

There is no indication of any contamination in the oil.

The condition of the oil is acceptable for the time in service.

Resample at the next service interval to monitor.
