OIL ANALYSIS REPORT

Machine Id
CATERPILLAR R1600H SCP222
 Component
Front Left Planetary
 Fluid
PETRO CANADA PRODURO TO-4 SAE 50 (--- GAL)

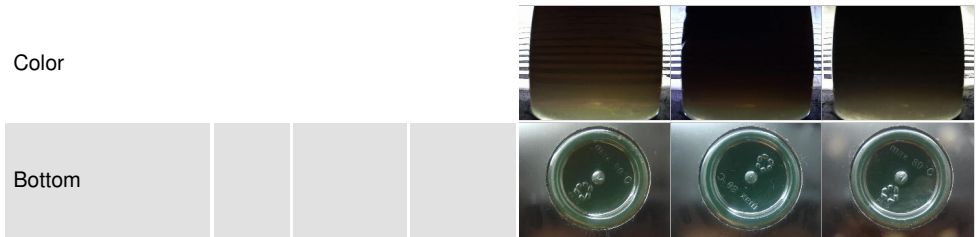
SAMPLE IMAGES	method	limit/base	current	history1	history2
---------------	--------	------------	---------	----------	----------

VISUAL	method	limit/base	current	history1	history2
White Metal	scalar	Visual*	NONE	VLITE	NONE
Yellow Metal	scalar	Visual*	NONE	NONE	NONE
Precipitate	scalar	Visual*	NONE	NONE	NONE
Silt	scalar	Visual*	NONE	NONE	NONE
Debris	scalar	Visual*	NONE	VLITE	NONE
Sand/Dirt	scalar	Visual*	NONE	NONE	VLITE
Appearance	scalar	Visual*	NORML	NORML	NORML
Odor	scalar	Visual*	NORML	NORML	NORML
Emulsified Water	scalar	Visual*	>0.2	NEG	NEG
Free Water	scalar	Visual*		NEG	NEG

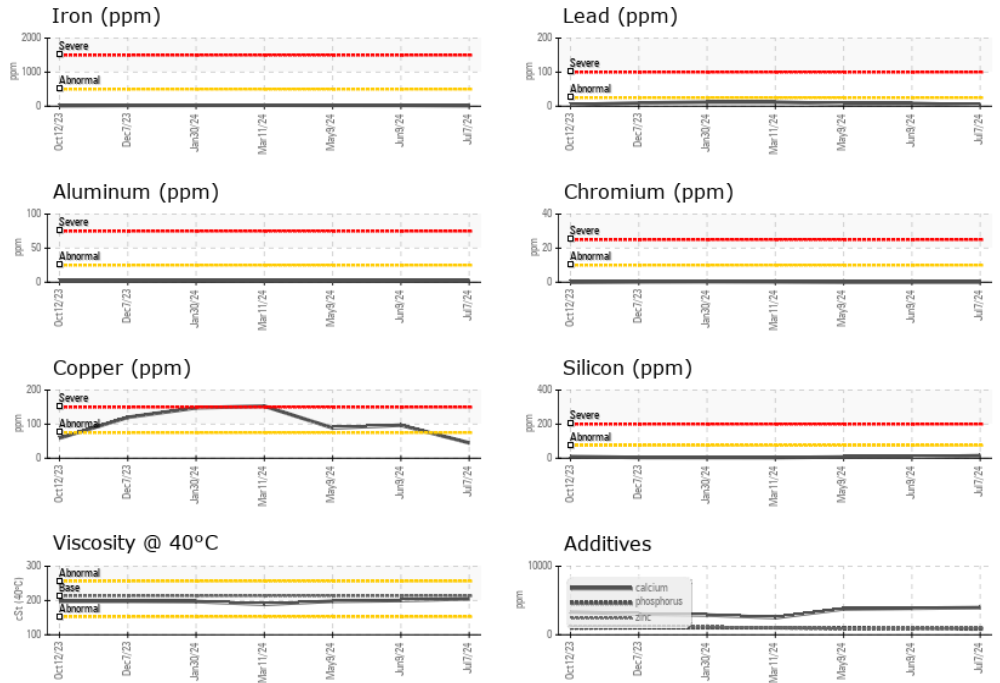
GRAPHS

method	limit/base	current	history1	history2	
Iron	ppm	ASTM D5185(m)	>500	14	24	25
Chromium	ppm	ASTM D5185(m)	>10	0	0	0
Nickel	ppm	ASTM D5185(m)	>10	<1	<1	<1
Titanium	ppm	ASTM D5185(m)		0	0	0
Silver	ppm	ASTM D5185(m)		0	0	0
Aluminum	ppm	ASTM D5185(m)	>25	2	2	2
Lead	ppm	ASTM D5185(m)	>25	4	8	8
Copper	ppm	ASTM D5185(m)	>75	45	97	89
Tin	ppm	ASTM D5185(m)	>10	3	4	4
Antimony	ppm	ASTM D5185(m)	>5	0	0	0
Vanadium	ppm	ASTM D5185(m)		0	0	0
Beryllium	ppm	ASTM D5185(m)		0	0	0
Cadmium	ppm	ASTM D5185(m)		0	0	0
