OIL ANALYSIS REPORT

Machine Id
CATERPILLAR R1600H SCP222
 Component
Front Right Planetary
 Fluid
PETRO CANADA PRODURO TO-4 SAE 50 (--- GAL)

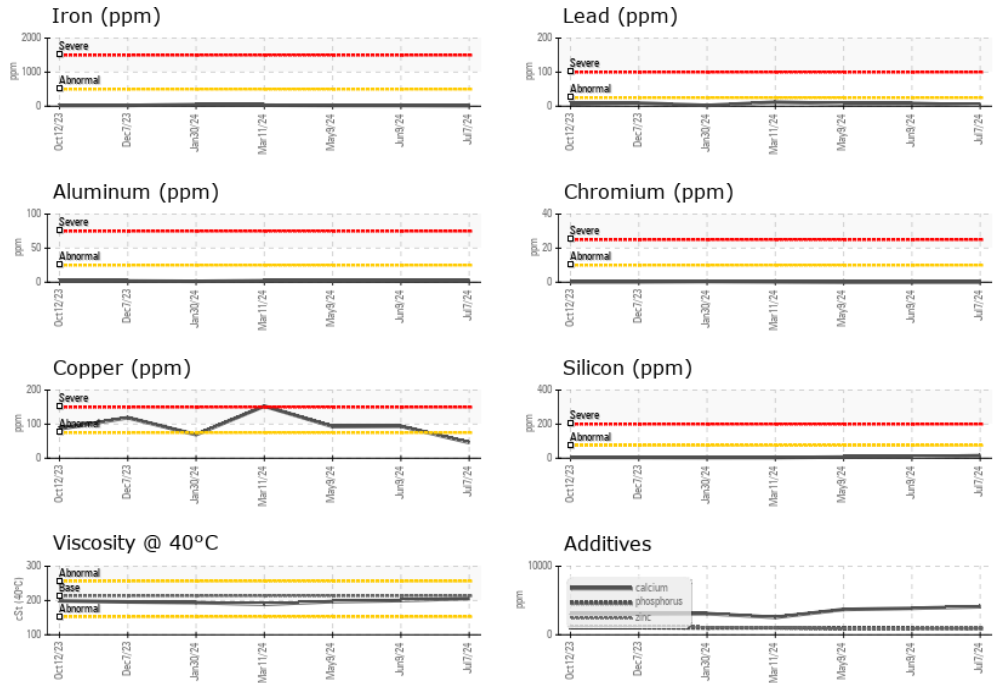
GRAPHS

All component wear rates are normal.

There is no indication of any contamination in the oil.

The condition of the oil is acceptable for the time in service.

Resample at the next service interval to monitor.
