OIL ANALYSIS REPORT

Machine Id
3270694
 Component
Gearbox
 Fluid
MOBIL GEAR (66 QTS)

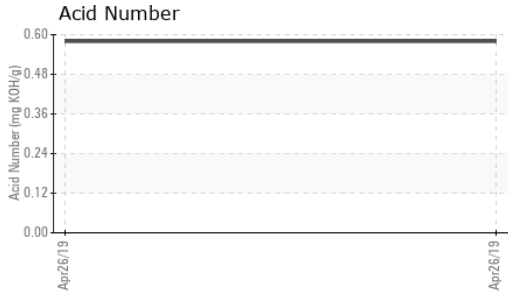
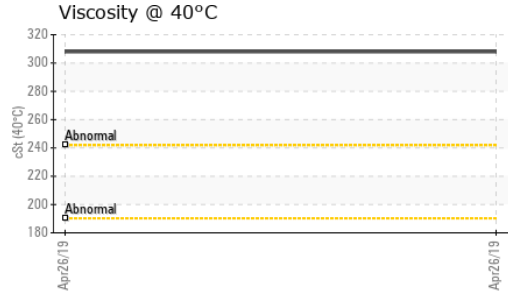
| SAMPLE IMAGES | method | limit/base | current | history1 | history2 |

| Color | | | | no image | no image |
| Bottom | | | | no image | no image |

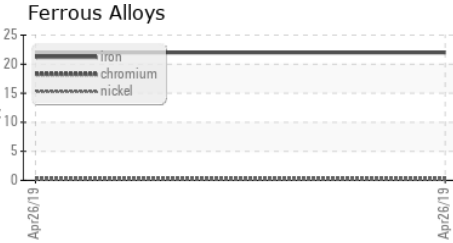
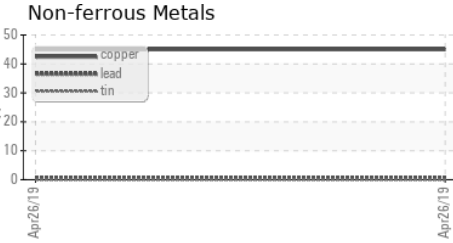
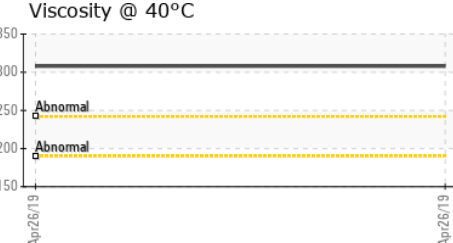
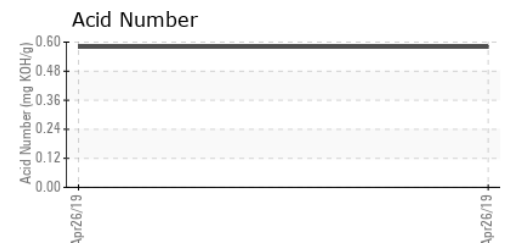
GRAPHS

All component wear rates are normal.

There is no indication of any contamination in the oil.

The AN level is acceptable for this fluid. The condition of the oil is suitable for further service.

Resample at the next service interval to monitor.
