OIL ANALYSIS REPORT

Area
P1
Machine Id
3104 - 3101 EVAPORATOR
Component
Gearbox
Fluid
MOBIL MOBILGEAR 600 XP ISO 150 (15 QTS)

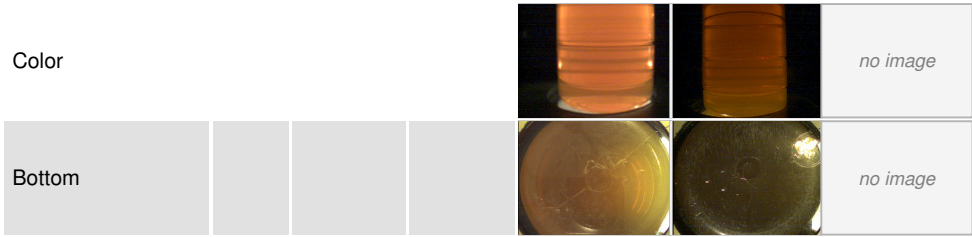
| SAMPLE IMAGES | method | limit/base | current | history1 | history2 |

| VISUAL | method | limit/base | current | history1 | history2 |
|---|---|---|---|---|---|
| Appearance | scalar | *Visual | NORML | NORML | --- |
| Odor | scalar | *Visual | NORML | NORML | --- |
