Machine Id
AC-5 (S/N AIF059824)
 Component
Air Compressor
 Fluid
ATLAS COPCO ROTO Z FLUID (--- GAL)

Customer Id: KRAWIN
 Sample No.: USPM23965
 Lab Number: 05623078
 Test Package: IND 2

OIL ANALYSIS REPORT

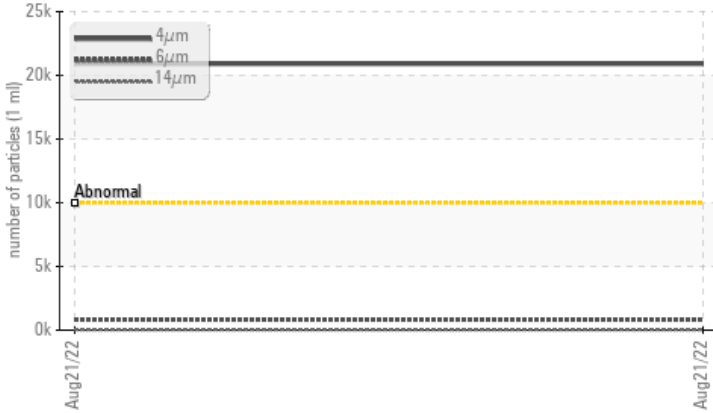
▲ Particle Trend

Sample Status			ABNORMAL	---	---
Particles >4µm	ASTM D7647	>10000	▲ 20904	---	---
Oil Cleanliness	ISO 4406 (c)	>20/18/15	▲ 22/17/12	---	---

There is a high amount of silt (particulates < 6 microns in size) present in the oil.

Resample at the next service interval to monitor.
