Machine Id
50638015 (S/N 13786)
 Component
Hydraulic System
 Fluid
MOBIL DTE 24 (--- GAL)

Customer Id: TECGRENC
 Sample No.: WC0731044
 Lab Number: 05651434
 Test Package: PLANT

OIL ANALYSIS REPORT

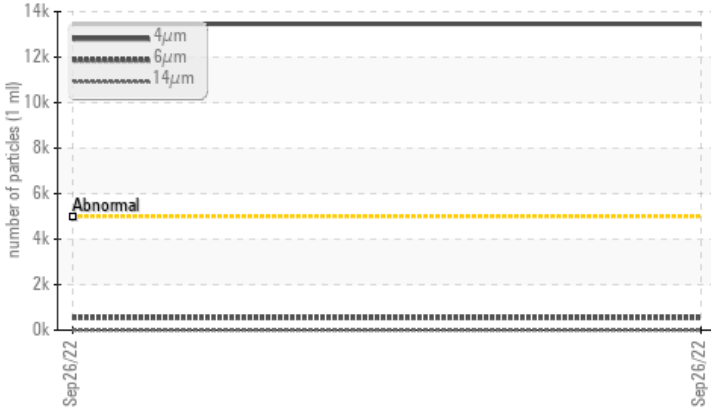
▲ Particle Trend

Sample Status			ABNORMAL	---	---
Particles >4µm	ASTM D7647	>5000	▲ 13463	---	---
Oil Cleanliness	ISO 4406 (c)	>19/17/14	▲ 21/16/10	---	---

There is a high amount of silt (particulates < 14 microns in size) present in the oil.

No corrective action is recommended at this time.
 Resample at the next service interval to monitor.

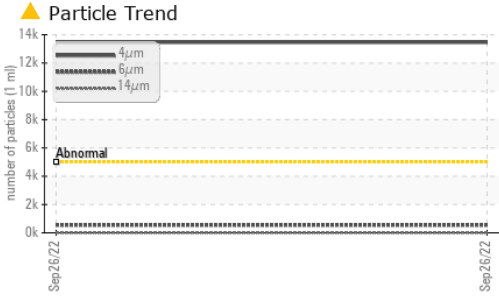
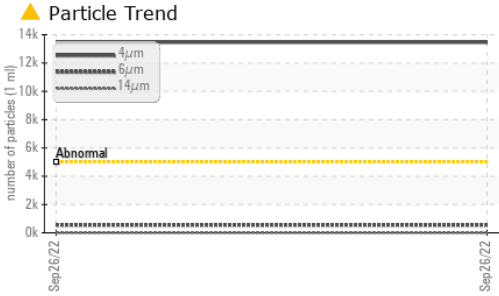
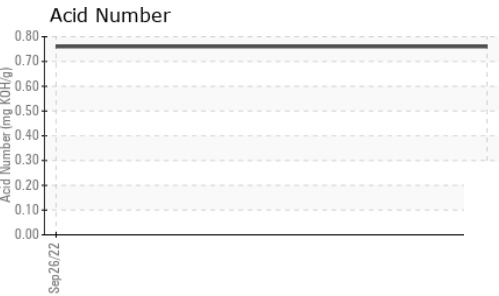
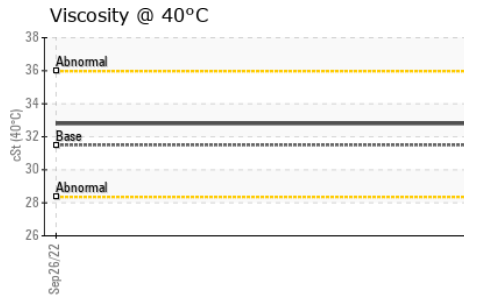
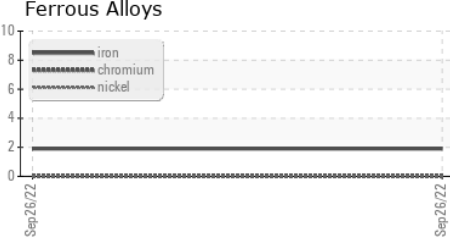
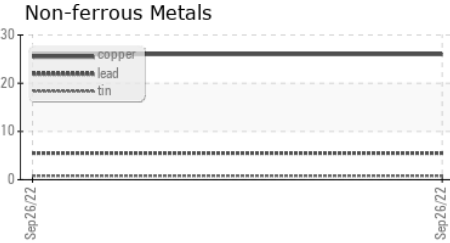
GRAPHS

method	limit/base	current	history1	history2
Particles >4µm	ASTM D7647 >5000	▲ 13463	---	---
Particles >6µm	ASTM D7647 >1300	548	---	---
Particles >14µm	ASTM D7647 >160	6	---	---
Particles >21µm	ASTM D7647 >40	2	---	---
Particles >38µm	ASTM D7647 >10	1	---	---
Particles >71µm	ASTM D7647 >3	0	---	---
Oil Cleanliness	ISO 4406 (c) >19/17/14	▲ 21/16/10	---	---
