Machine Id
50499519 (S/N 13662)

Component
Hydraulic System

Fluid
MOBIL DTE 24 (--- GAL)

OIL ANALYSIS REPORT

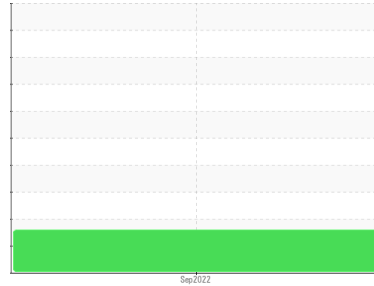
Sample Rating Trend

The copper level is abnormal. All other component wear rates are normal.

Resample at the next service interval to monitor.

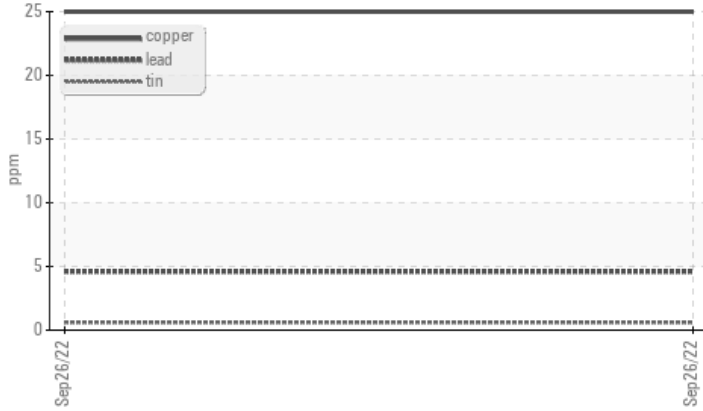
▲ Non-ferrous Metals

Sample Status				ABNORMAL	---	---
Copper	ppm	ASTM D5185m	>20	▲ 25	---	---
Particles >4µm		ASTM D7647	>5000	▲ 6110	---	---
Oil Cleanliness		ISO 4406 (c)	>19/17/14	▲ 20/17/12	---	---

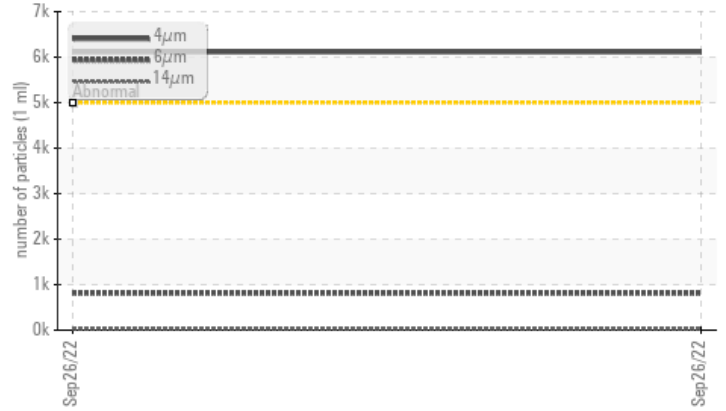
▲ Particle Trend

There is a moderate amount of silt (particulates < 14 microns in size) present in the oil.

method	limit/base	current	history1	history2
Particles >4µm	ASTM D7647	>5000	▲ 6110	---	---
Particles >6µm	ASTM D7647	>1300	811	---	---
Particles >14µm	ASTM D7647	>160	31	---	---
Particles >21µm	ASTM D7647	>40	4	---	---
Particles >38µm	ASTM D7647	>10	0	---	---
Particles >71µm	ASTM D7647	>3	0	---	---
Oil Cleanliness	ISO 4406 (c)	>19/17/14	▲ 20/17/12	---	---

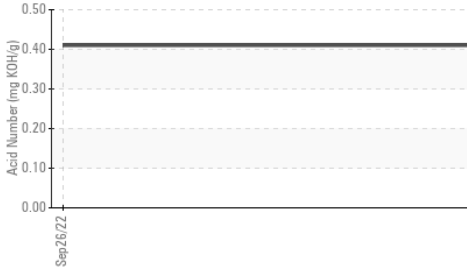
The AN level is acceptable for this fluid. The condition of the oil is acceptable for the time in service.

method	limit/base	current	history1	history2
Acid Number (AN)	mg KOH/g	ASTM D8045	0.41	---	---

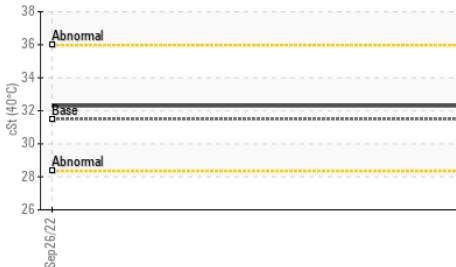
Viscosity @ 40°C

FLUID PROPERTIES	method	limit/base	current	history1	history2
Visc @ 40°C	cSt	ASTM D445	31.5	32.3	---
