Machine Id
49239508 (S/N 13340)
Component
Hydraulic System
Fluid
MOBIL DTE 24 (--- GAL)

OIL ANALYSIS REPORT

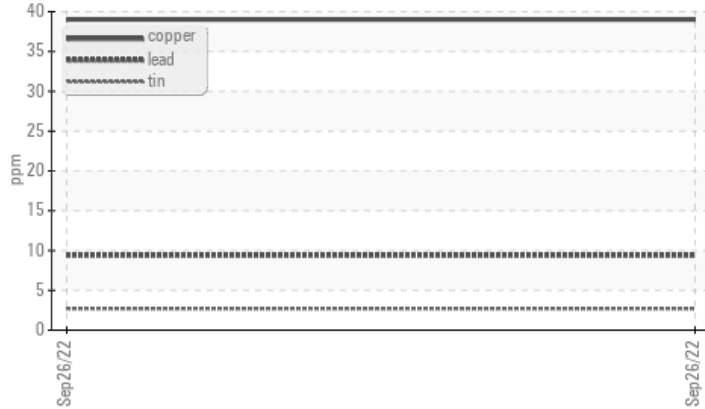
COMPONENT CONDITION SUMMARY

▲ Non-ferrous Metals

Sample Status				ABNORMAL	---	---
Copper	ppm	ASTM D5185m	>20	▲ 39	---	---

The copper level is abnormal. All other component wear rates are normal.

No corrective action is recommended at this time.
Resample at the next service interval to monitor.

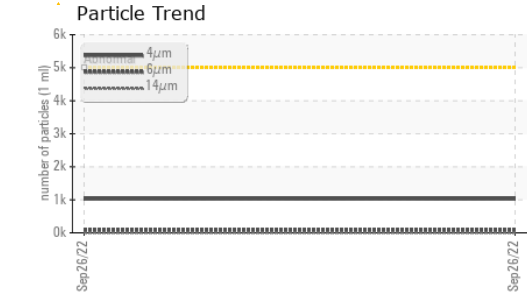
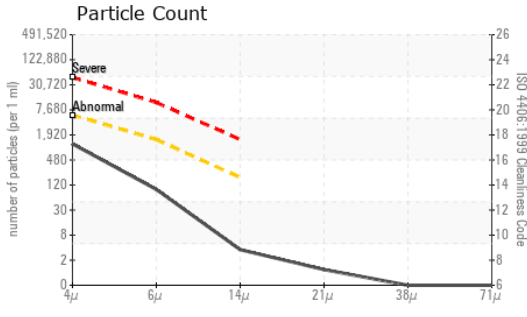
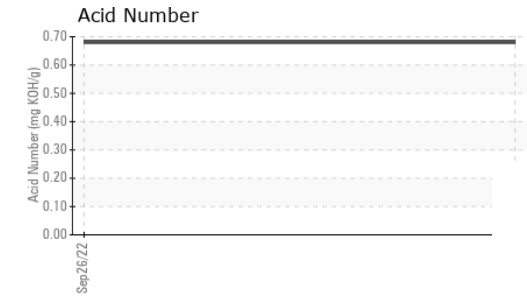
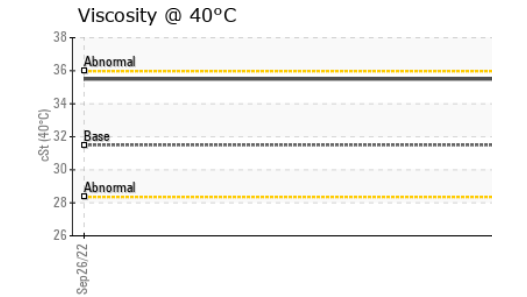
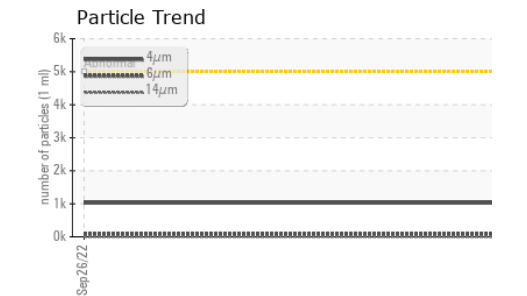
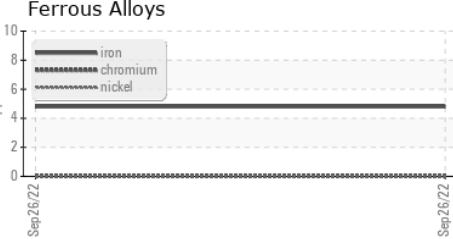
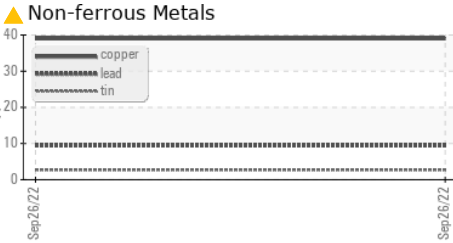
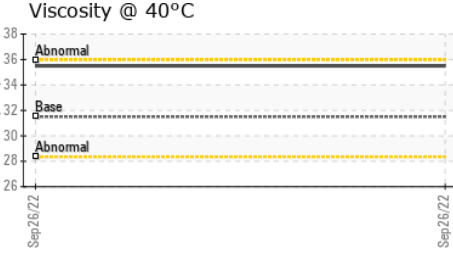
GRAPHS

The AN level is acceptable for this fluid. The condition of the oil is acceptable for the time in service.

No corrective action is recommended at this time. Resample at the next service interval to monitor.
