PROBLEM SUMMARY

Machine Id
50499516 (S/N R-02630R)
Component
Hydraulic System
Fluid
MOBIL DTE 24 (--- GAL)

OIL ANALYSIS REPORT

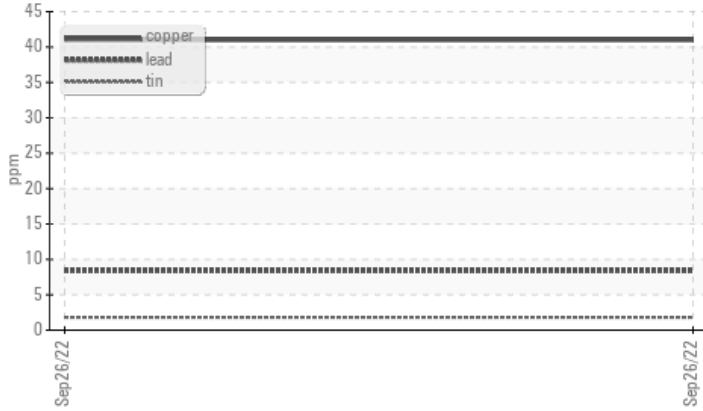
COMPONENT CONDITION SUMMARY

▲ Non-ferrous Metals

Sample Status				ABNORMAL	---	---
Copper	ppm	ASTM D5185m	>20	▲ 41	---	---

Wear
 The copper level is abnormal. All other component wear rates are normal.

No corrective action is recommended at this time.
Resample at the next service interval to monitor.
